A Basic Study of the Relationship between Earthquakes Kushiro-Oki and Hokkaido-Nansei and the Resulting Damage to Concrete Structures*

Hiroshi SAKURAI,** Koichi AYUTA,** Noboru SAEKI*** Yoshio FUJITA****

3.1 Damage from Kushiro-Oki earthquake

3.2 Damage from Hokkaido nansei-oki earthquake

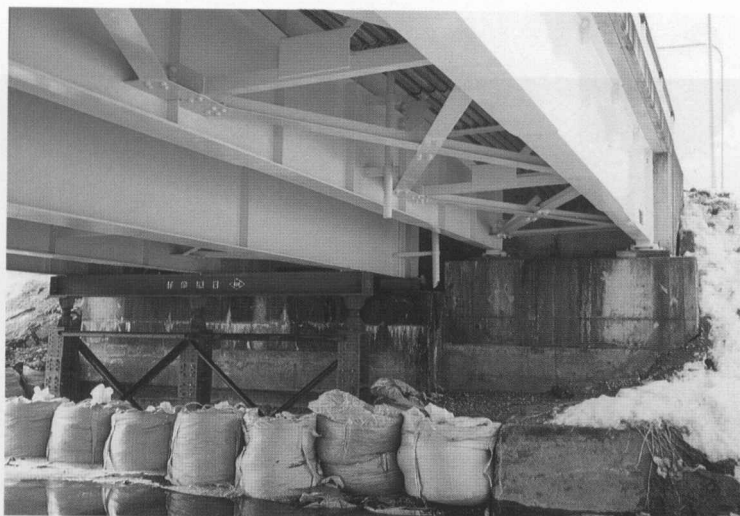
In this example, a road bridge pier (compound beam bridge, constructed in Urahoro in 1966) was cracked and the concrete was scaled. Because the base of the front of abutment pier was soft and peaty, the abutment pier and shore protection were pushed into the river bank and the girder moved in the line of its axis. The shoe and mortar of the bridge bearing were damaged. (Photo 1)

Photo-1 Movement of the abutment pier and shore protection
(compound beam bridge, constructed in 1966)

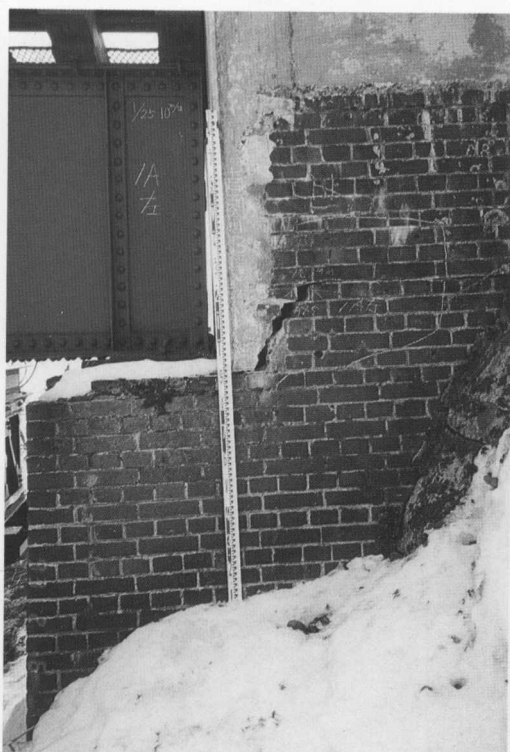
In this example, a girder of a railroad bridge (steel girder, between Cyokubetsu and Atunai constructed several decades ago using an abutment of wooden piles and laid bricks) smashed into the bridge abutment and moved in the axis of the girder. The abutment suffered a 45 mm width crack and is leaning vertically.

Photo-2 Crack and inclination of abutment

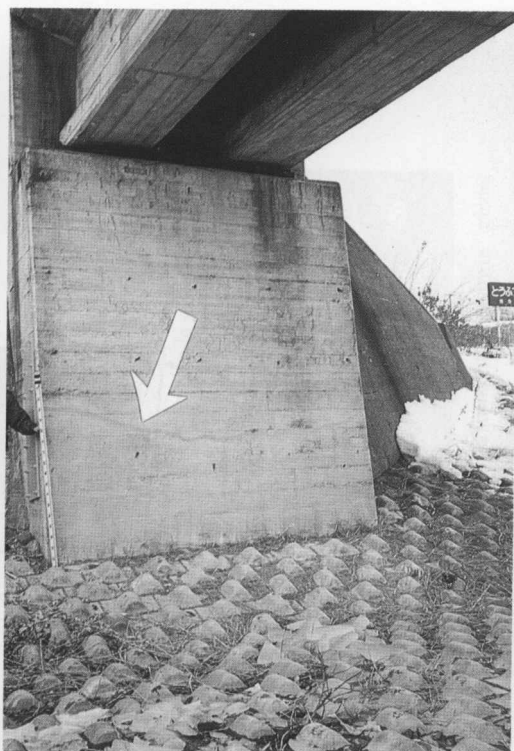
In another example, the abutment of another railroad bridge (T beam of RC, between Ikeda and Shoei) was cracked parallel to the ground at a point 50 cm above the reinforcing steel section decrease point. This was caused by hard shaking in the north/south direction. The shoe stopper was also damaged. (Photo 3)

Photo-3 Crack at 50 cm above reinforcing steel
girder, between Chokubetsu steel section
decreases point on and Atsunai abutment
(T-beam of RC, between Ikeda and Shoei).

Stress concentrated and cracks occurred at the points where longitudinal reinforcing steel was discontinued, showing the necessity of studying ways to prevent this.

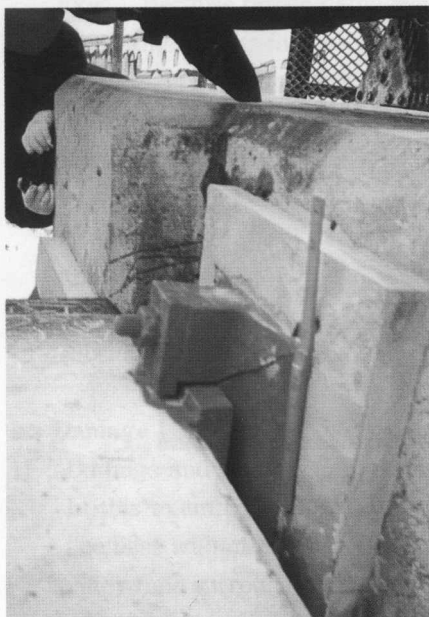
In another example, the stoppers of shoes of a railway bridge (PC Girder, between Ineshi and Makubetsu) were damaged at the movable shoe of the first pier (1P) and in the slide stopper of the shoe on the fifth pier (5P) (Photo 4B).

Pohto-4B Broken slide stopper of shoe (PC girder bridge, between Ineshi and Makubetsu)

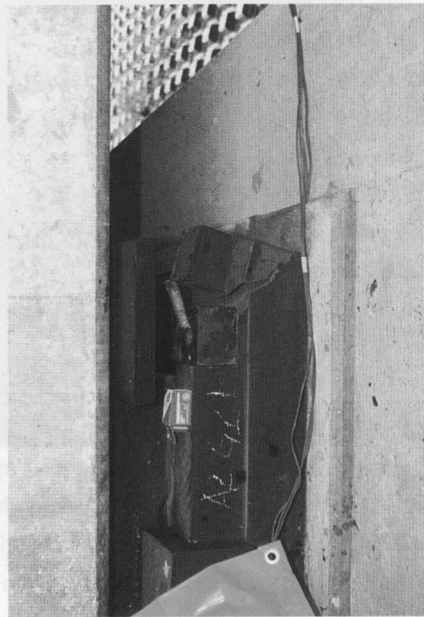
In yet another example, a road bridge (PC box girder bridge, constructed in 1991, Urahoro) was damaged by shaking in the direction of the girder. The shoes were damaged and the expansion joint was separated from the bridge parapet. Cracking occurred in the concrete at joint edge and the pavement and footpath behind the bridge abutment subsided (Photo 5).

Pohto-5 Broken shoe (PC box girder bridge, constructed in 1991, Urahoro)

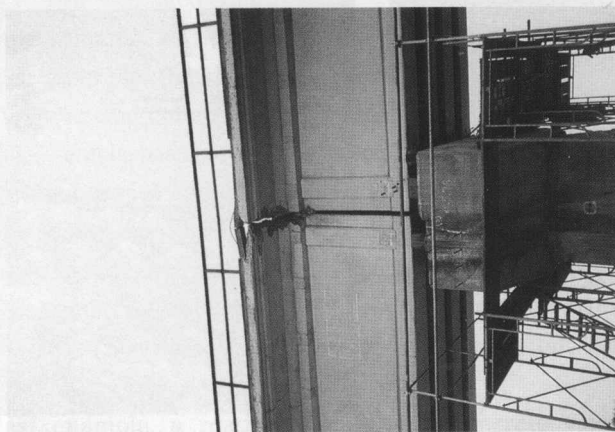
between Hobetsu and Ikeda) was damaged by north/south shaking along the girders' axes. Because of the damage to the shoe, the girders' edges were cracked and scaled, especially in the ninth pier (9P) and the edges of the ninth girder. (Photo 4A)

Pohto-4A Broken shoe and concrete girder sedges (PCT : T beam of prestressed concrete bridge, between Hobetsu and Ikeda)

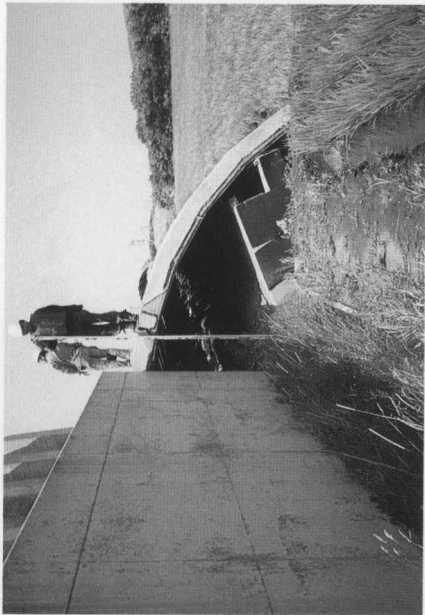
In this example, a snow shed (PC arch structure, Senjyouzaka in Okushiri) collapsed. The base wall of the arch fell outward and the arch collapsed because liquefaction of the paddy field surrounding the structure's base caused the horizontal wall to lose resistance. Prior to this collapse, the structure appeared to reach its limit of stability. The shed experienced hard shaking along its axis (the progress direction) and vertically and the arch parts slid about 30 cm, yet the structure did not fail until liquefaction occurred (Photo 6).

Pohto-6 The collapsed base wall of arch and the collapsed arch (PC arch structure Senjyozaka in Okushiri, just before completion in July 1993)

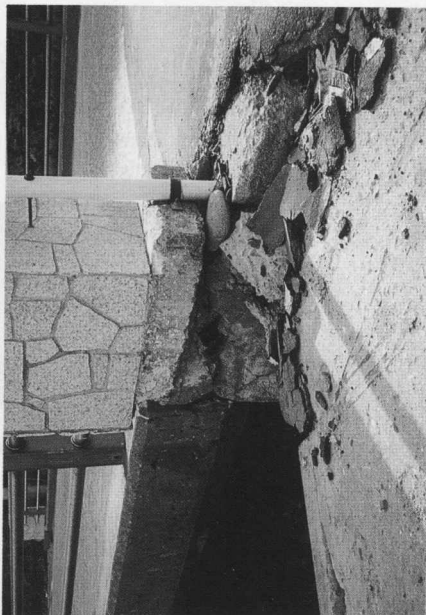
In this example, the outside abutment of a road bridge (concrete girder bridge, Okushiri in Okushiri) was damaged (Photo 8).

Pohto-8 Broken concrete of abutment (concrete girder bridge, Okushiri in Okushiri)

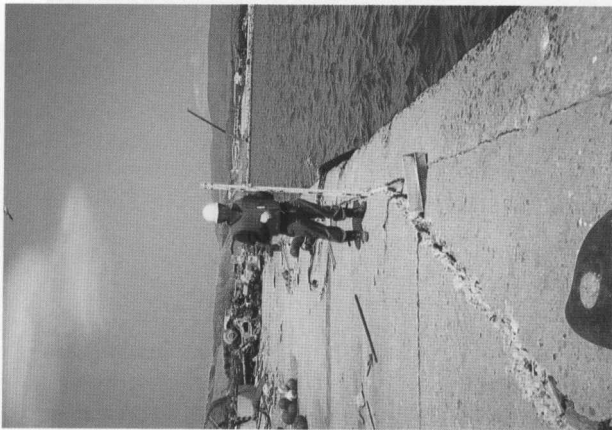
In another example, a lighter's wharf (concrete plate, Aonae in Okushiri) was damaged by the liquefaction and loss of bearing value of its base. The concrete plates were cracked, broken, and faulted due to differential settlement (Photo 7).

Pohto-7 Crack and breaking on lighter s wharf (concrete plate, Aonae in Okushiri)

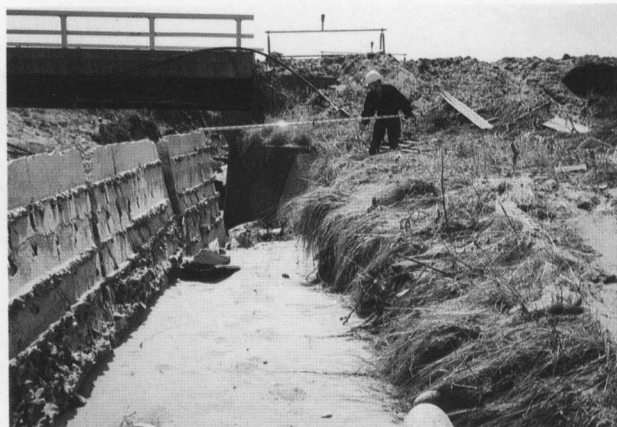
In the first example, the shore protection of a road bridge (concrete block, Aonae in Okushiri) moved and collapsed due to retreating tsunami carrying back filling material. In this case, vehicle passage was still possible (Photo 9).

Photo-9 Moving and collapsing retaining wall due to retreating tsunami (concrete retaining wall, Matsumae in Okushiri)

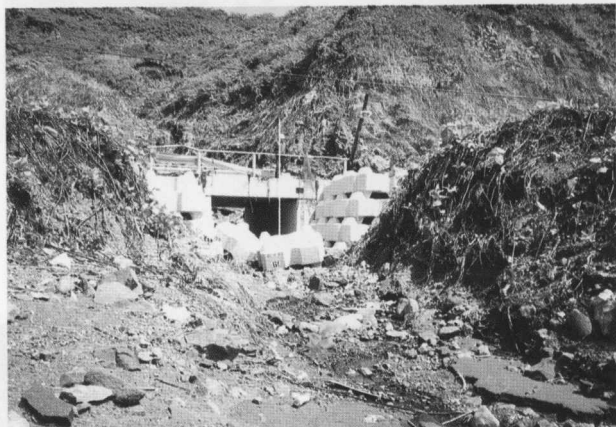
Similarly, the parapet and abutment of a road bridge (concrete girder bridge Monai in Okushiri) was damaged by tsunami (Photo 10).

Photo-10 Damage to parapet and abutment (concrete girder bridge, Monai in Okushiri)

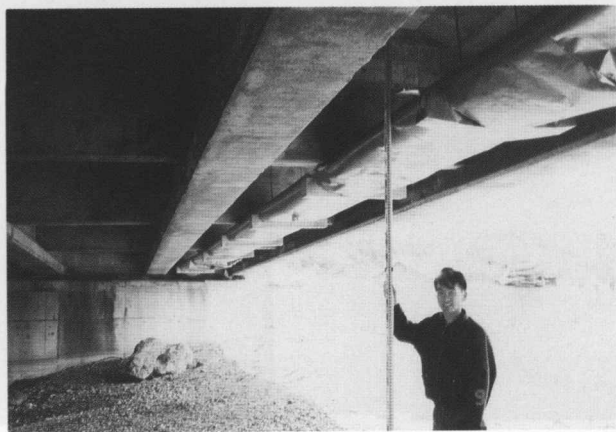
In another example, steel plate covers of a water supply pipe under the river side of a road bridge (concrete girder bridge, Shimamaki) were deformed by tsunami (Photo 11). Tsunami washed over the floor slabs of this bridge, but, for the most part, bridge movement could not be detected.

Photo-11 Deformation of steel plate covers of water supply pipe underneath, as caused by tsunami (concrete girder bridge, Shimamaki)

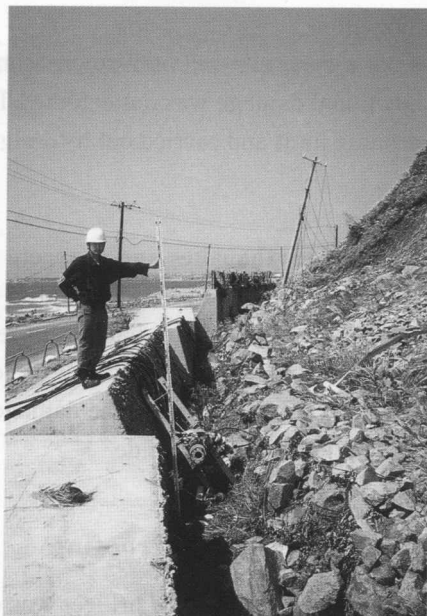
In the last example, a road retaining wall (concrete retaining wall, Mastumae in Okushiri) collapsed on the seaward side because a retreating tsunami washed over the road and retaining wall. The mat foundations were not able to resist the force of the retreating tsunami (Photo 12).

Photo-12 Collapsed road retaining wall
caused by retreating tsunami
(concrete retaining wall, Mat-
sumae in Okushiri)

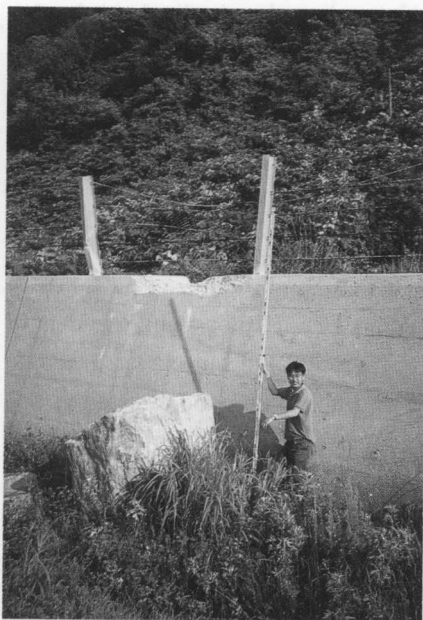
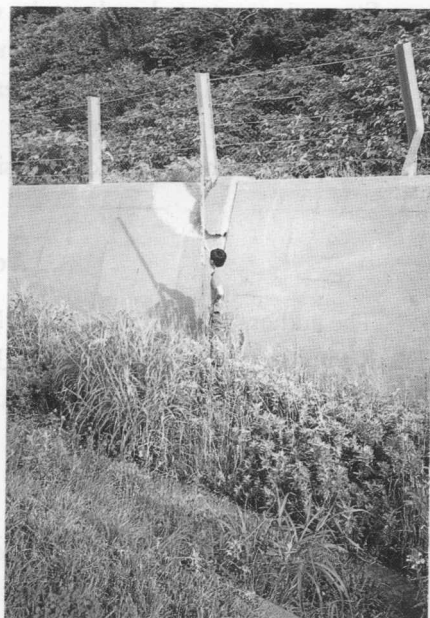
Photo-13 Falling stones caused by earth-
quake and damage to retaining
wall (concrete retaining wall,
Shimamaki)

Photo-14 Broken root concrete of falling
stone protection fall (concrete
retaining wall, Shimamaki)

In this example, the roots of a concrete wall built to prevent falling stones was cracked and damaged, although functional damage was not detected. The wall reached its state of usable limit, but not its ultimate limit and carried out its designed function (Photos 13 and 14) .
