Study of the relationship between recent large earthquakes and damage to concrete structures*1

Hiroshi SAKURAI*2, Koichi AYUTA*2,
Noboru SAEKI*3, Kaneyoshi OKADA*2

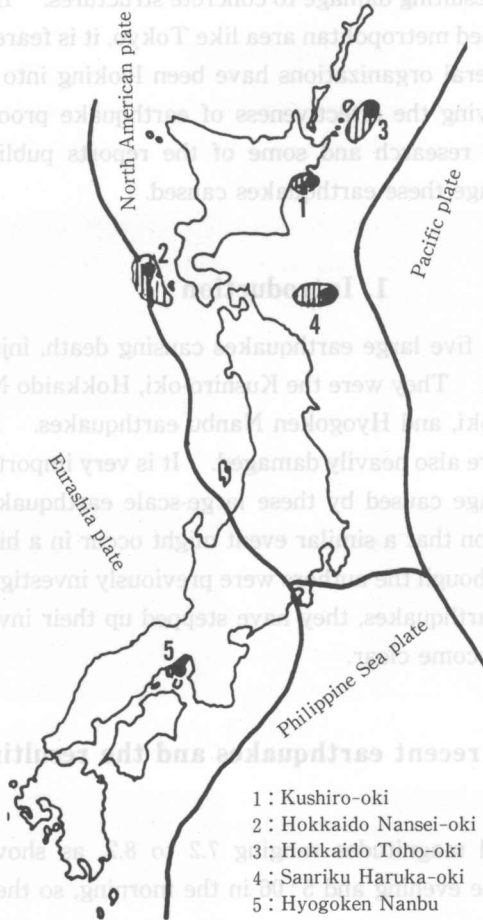
Fig.1 Locations of earthquakes

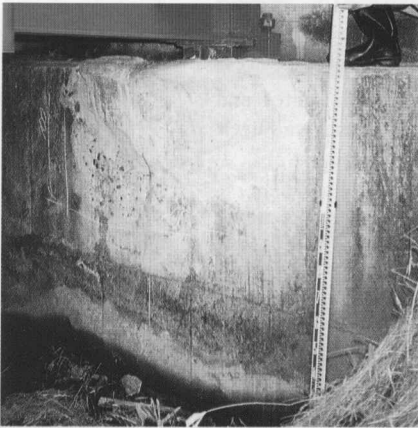
Photo 1 Failure of the anchor support, cracking, and scaling of the concrete abutment (Road bridge, composite girder, Manmen in Bekkai town)

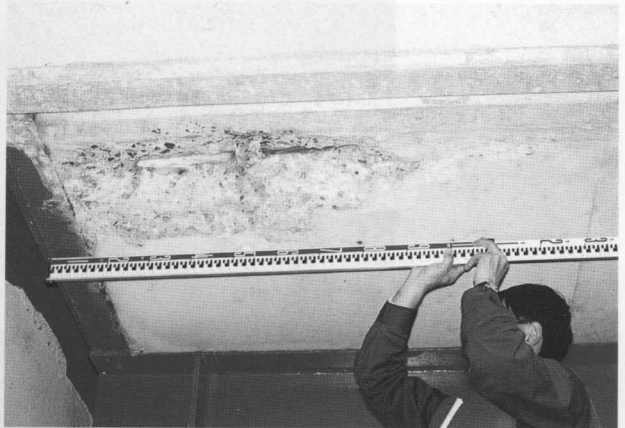
Photo 2 Failure and scaling of concrete, exposure of stirrup steel, and other damage were caused when the girder was crushed against the abutment (Road bridge, composite girder, Furen in Bekkai town)

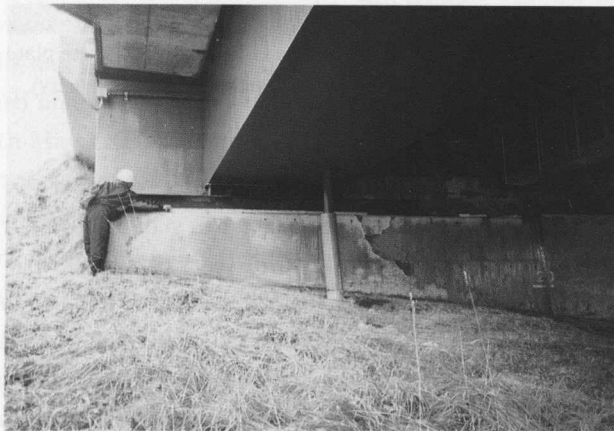
Photo 3 Failure of the anchor support, cracking, and scaling of the concrete abutment. The width of the abutment: 275 cm at the upper part and 460 cm at the lower part. (Road bridge, 3 spans continuous, 2 main girders box section, Midorimachi in Nakashibetsu town)

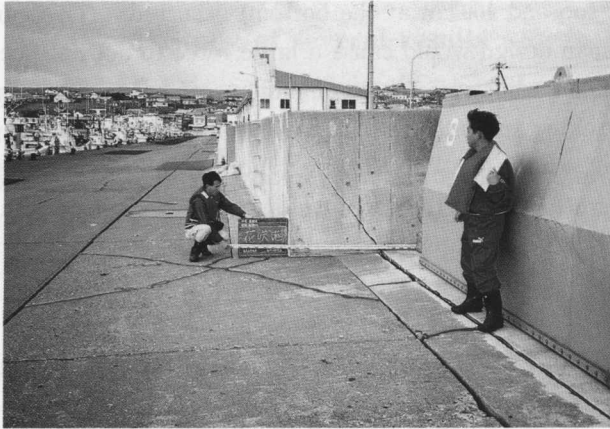
Photo 4 Cracking at the concrete base for the gates and shear cracks on the anti-tidal wave quaywall itself (Fishing port, Hanasaki in Nemuro city)

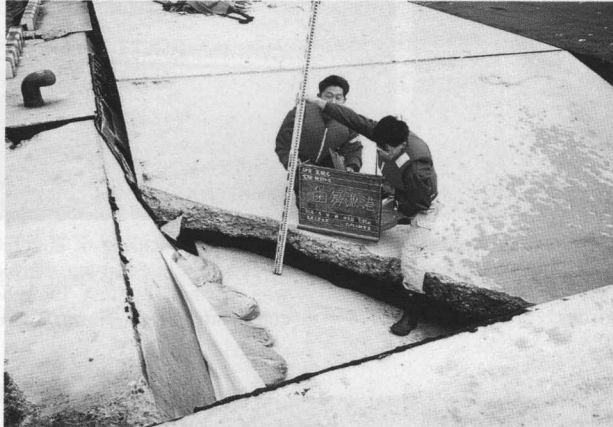
Photo 5 Wharf tilted and sunk and broke the concrete plate of apron (Fishing port, habomai in Nemuro city)

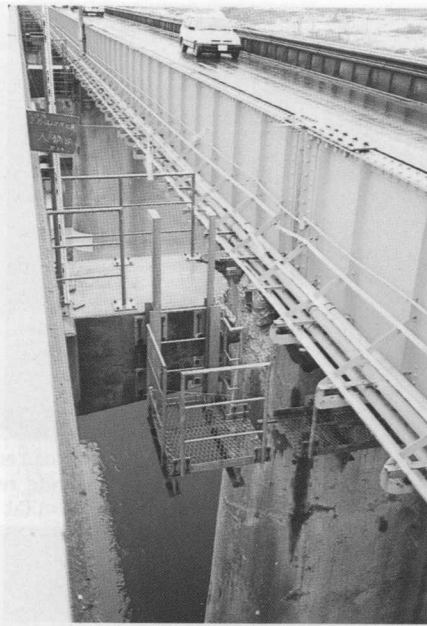
Photo 6 Concrete pier of steel girder bridge tilted and damage a part of concrete pier of pedestrian bridge by crashing onto each other (Road bridge: constructed in 1931, pedestrian bridge: constructed more in 1972, Kumanodou — Naganawashironai Funawatasi in Hachinohe city)

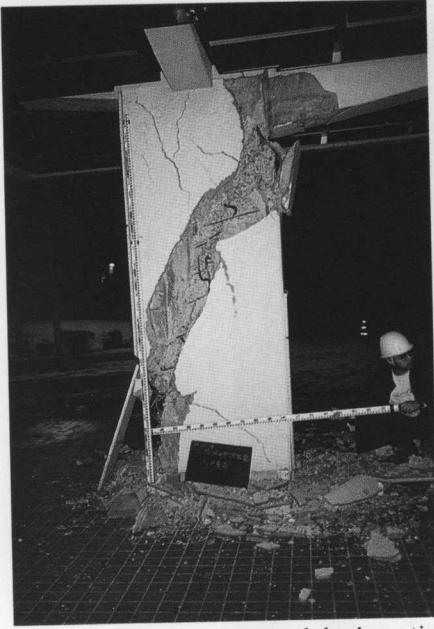
Photo 7 Concrete destroyed, broken stirrups, deformation and yield of longitudinal steel at recessed steel section past of RC pier (the first floor of 3 stories high school building in Hachinohe city)

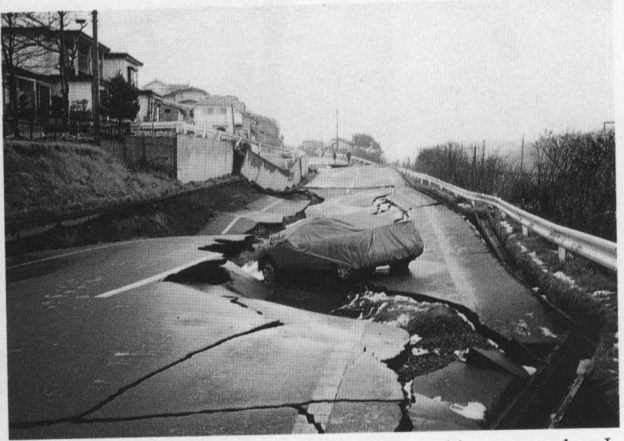
Photo 8 Collapse of a road embankment subbase caused an L-shaped concrete retaining wall to slide 3.5 m and subside by 2.5 m (at Matsugaoka in Hachinohe city)

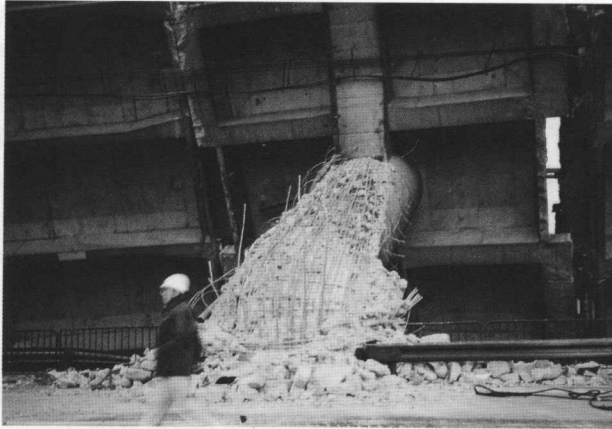
Photo 9 Expressway piers and girders failed and collapsed (PC bridge constructed in 1969, at Fukae honjyo-cho, Higashinada Ward in Kobe city)

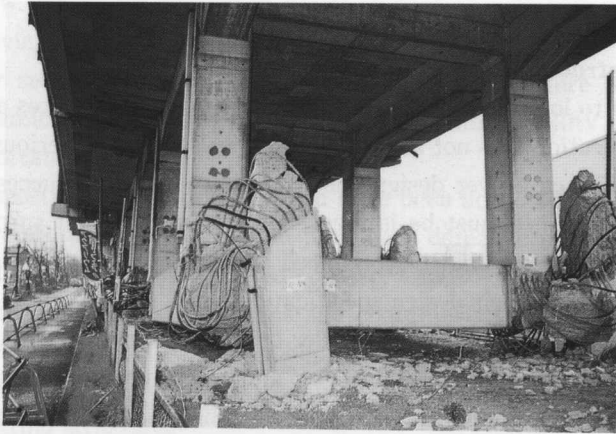
Photo 10 Concrete destroyed, stirrups failed and the longitudinal reinforcing steel yielded and deformed at recessed part of RC pier (Express railway bridge, PC girder, near Mukogawa river in Nishinomiya city)

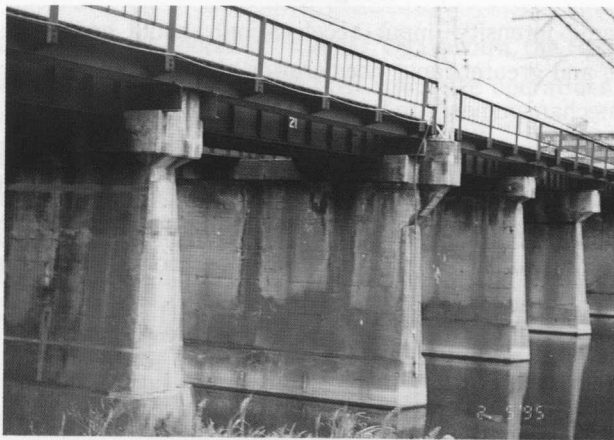
Photo 11 Undestroyed RC pier (Rail way bridge, steel girder, constructed in 1926, Mukogawa river in Nishinomiya city)
