Research on RC structure housing an old communication system for northern territory*¹

Hiroshi SAKURAI*², Kaneyoshi OKADA*² and Noboru SAEKI*³

Abstract

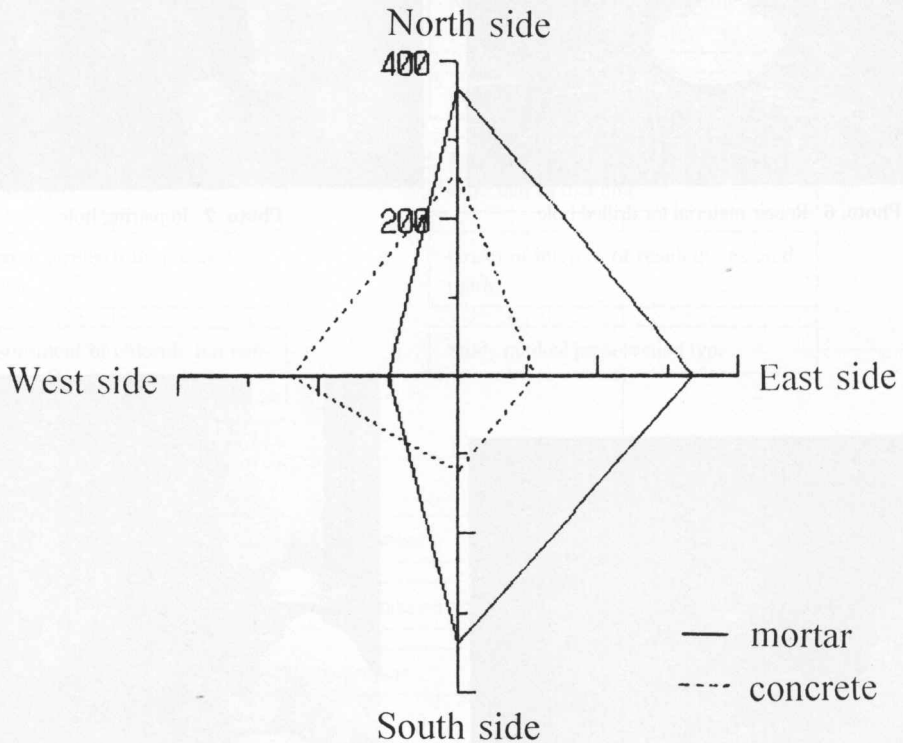
Fig. 3. 1. 1 Strengths of mortar and concrete obtained on each side wall by means of Schmidt hammer.

The strength of mortar and concrete of the structure housing the communication system obtained by means of Schmidt hammer at each side wall are shown in Fig. 3.1.1. The strength of mortar is from 360 kgf/cm² to 100 kgf/cm² stronger than concrete which is from 250 kgf/cm² to 120 kgf/cm², expect the west side. The strength of concrete and mortar on the north side are the strongest because of fewer freeze and thaw cycles than the other side. Greater mortar strength is advantageous for protecting concrete as shown in Photo. 25.

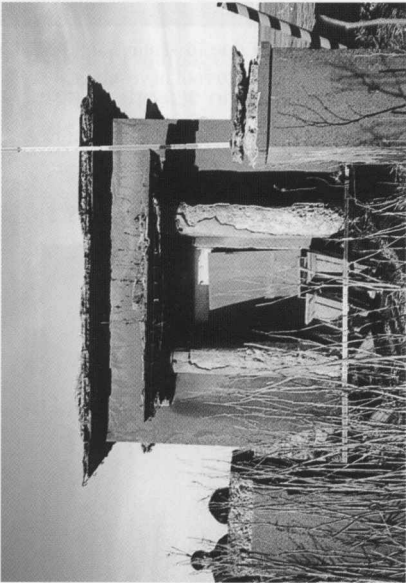
The edge and corner mortar of the exterior wall, concrete of the building frame and concrete of the lean-to roof were deteriorated and delaminated due to frost damage, especially at the south and west sides (as shown in Photo. 10,11,12 and 13), because the sides and edge (as shown in Photo. 14, 15, 16, 17, 18, and 19), sustained many freeze and thaw cycles as a result of sunshine and change of temperature in winter.

Photo. 10 The south side which has deteriorated due to many cycles of freeze and thaw with sunshine in winter

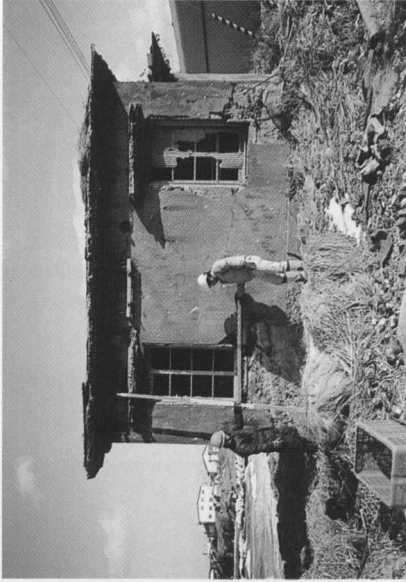
Photo. 11 The west side which is deteriorated due to many cycles of freeze and thaw with sunshine in the afternoon in winter

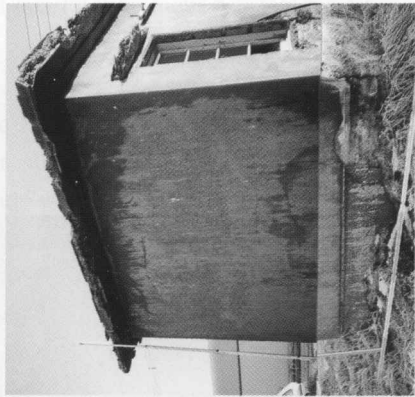
Photo. 12 The north side which has deteriorated comparatively light

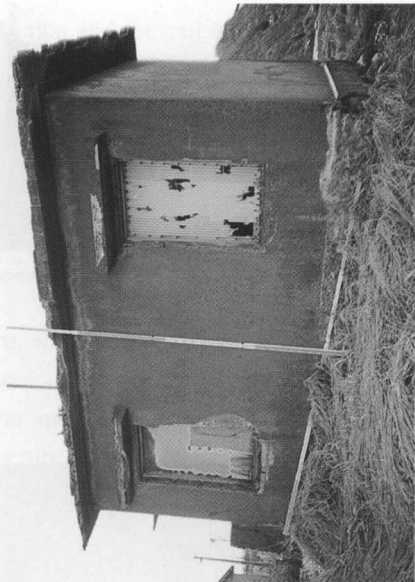
Photo. 13 The east side which has deteriorated comparatively light

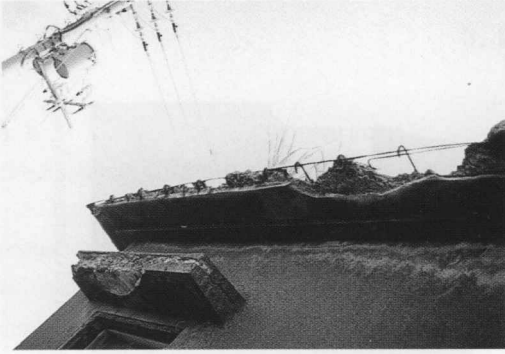
Photo. 14 Deterioration of lean-to roof on the west side

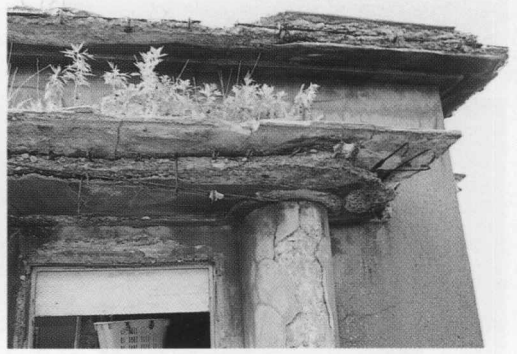
Photo. 15 Deterioration of lean-to roof of vestibule of on the south side

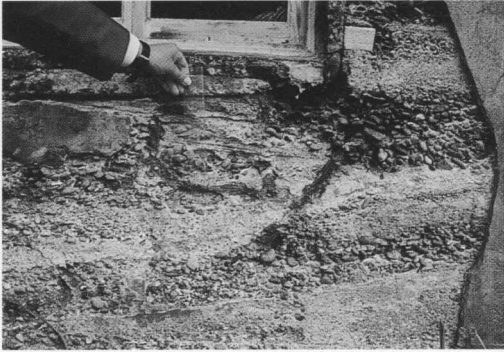
Photo. 16 Corrosion of steel in shallow depth under a window on the west side

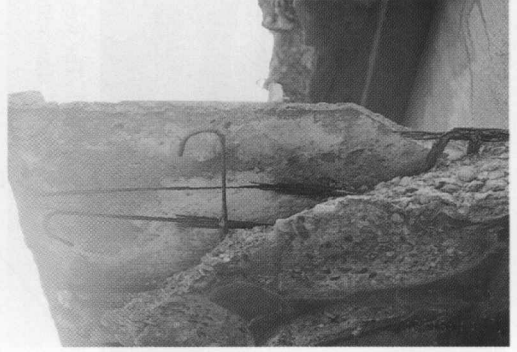
Photo. 17 Exposed steel due to scaling and spalling concrete of lean-to roof of vestibule

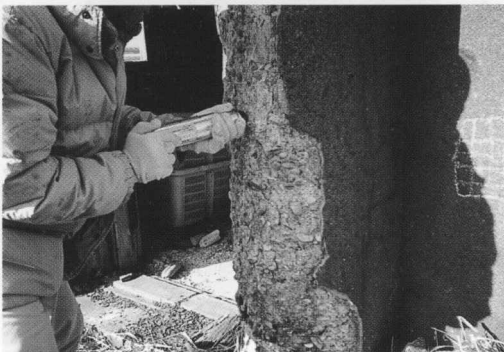
Photo. 18 Low repulsion of deteriorated part

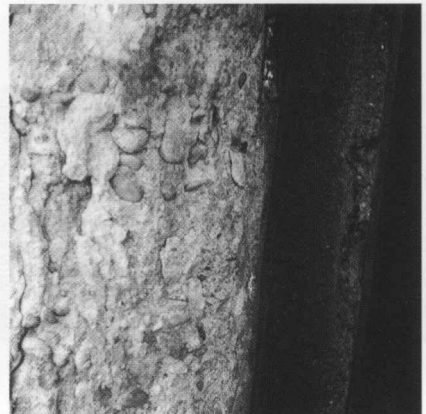
Photo. 19 Spalling of deteriorated part

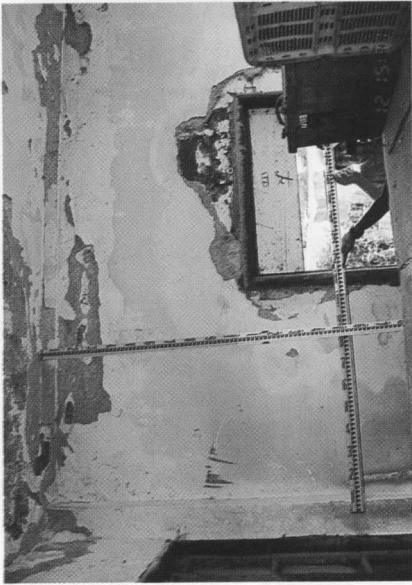
Leakage or frost damage on interior wall was not observed inside the structure, as shown in Photo. 20, 21, 22, and 23. The plaster has remained comparatively intact because of the finish with fibrous lathing which seems to serve as heat insulation and prevent internal condensation. There is no diagonal tension cracks although the structure had suffered from large earthquakes such as 1993 Kushiro-oki earthquake and 1994 Hokkaido-toho-oki earthquake recently examples, because solid wall girders and a ceiling girder at the center of the interior, 4 quoin posts at each corner, and a partition wall between main room and cable-pit room were installed to support the ceiling in the one-storied building as earthquake proof measures, as shown in Photo. 21 and 22.

Photo. 20 Plaster finished wall and plastered ceiling without leakage for a long year and quoin posts inside in the south side

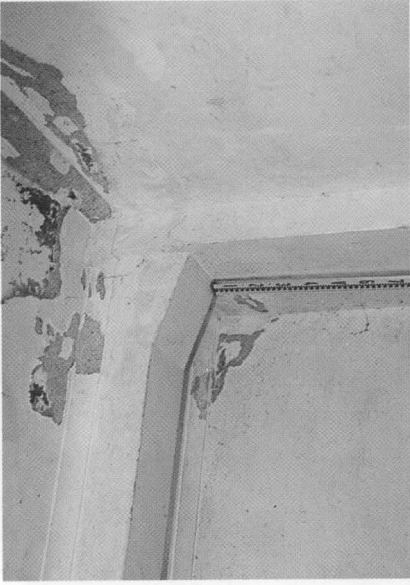
Photo. 21 Solid wall girder, ceiling girder and a partition wall between main room and cable-pit room at the center of the interior comparatively one-storied building, as measure fore earthquake proofing

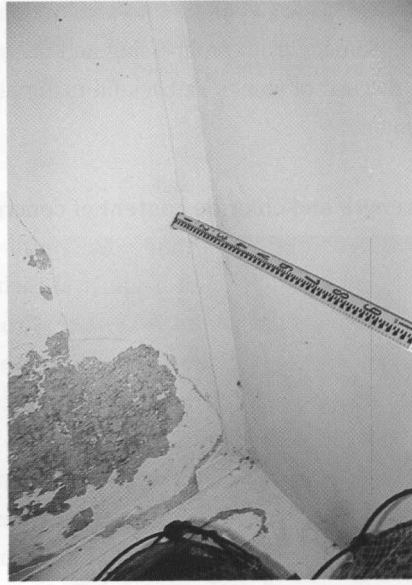
Photo. 22 Comparatively beautiful plaster and concrete on ceiling and partition wall in cable-pit room without leakage for long year.

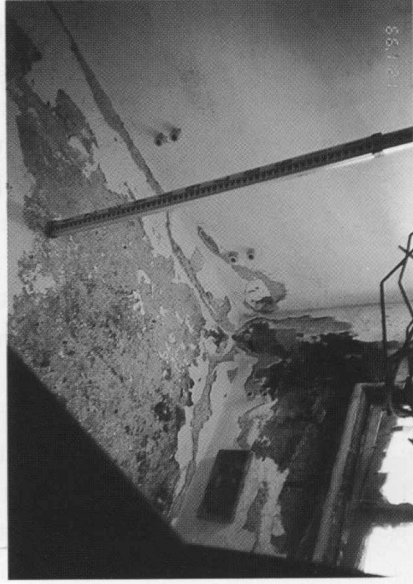
Photo. 23 Plaster finished wall and plastered ceiling at the west side in cable-pit room where insulators are installed.

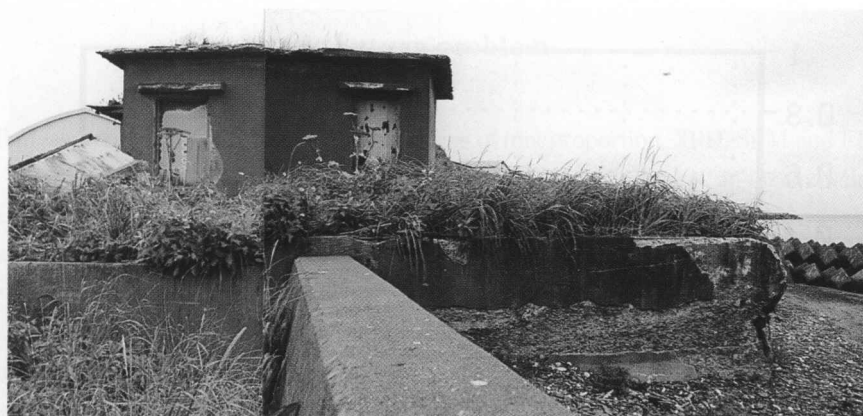
Photo. 24 Coastal revetment surrounding the structure, which is estimated to have been constructed at the same time, but this side is the present days.

It seems that the design of the structure and the coastal revetment surrounding the structure, whose section of the coastal revetment is rather thinner than the present design without reinforcing as shown in Photo-24, the construction, and the choice of building material such as concrete, finish mortar, reinforcing, and back-fill stone were excellent at the time when there were some restriction on internal deterioration factor control such as nonexistence of AE agent even if at present with cases happening non-reliable trouble rarely.

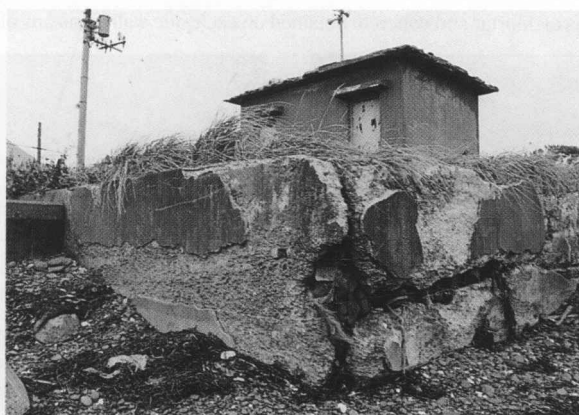
Photo. 25 Coastal revetment is reinforced concrete and stone were used as back-fill material.

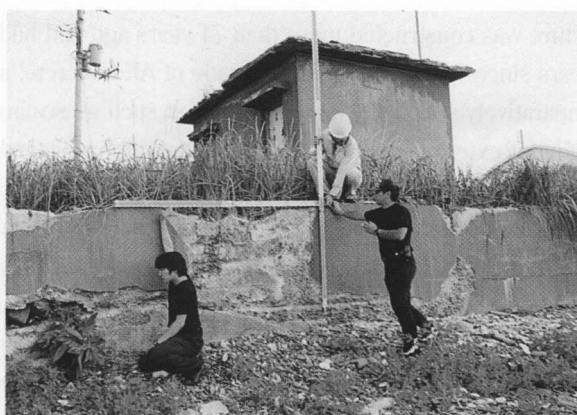
Photo. 26 Crack and deteriorated part of coastal revetment of the structure

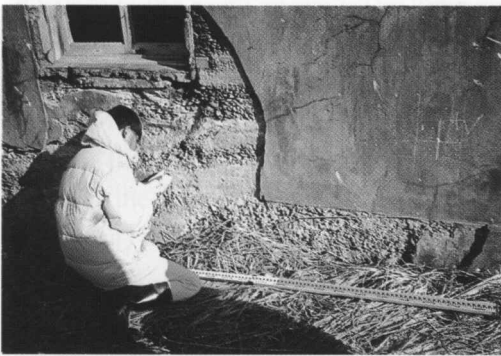
The structure and coastal revetment surrounding the structure are at a severe level of the serviceability limit state, nearing the ultimate limit state until some years as shown in Photo. 27 and 28. Repair that electric protection, desalinization of building frame concrete, reinforcement not relying on existing reinforcing steel, or corrosion prevent for exterior surface have to be enforced as soon as possible is demanded in decision by the former northern territory island residents and especially the residents in Nemuro city, that the structure be preserved in as the present condition, just before abandon to communicate for northern territory or the completing construction.

Photo. 27 Delaminated mortar finish and building frame concrete on exterior wall face at the west side

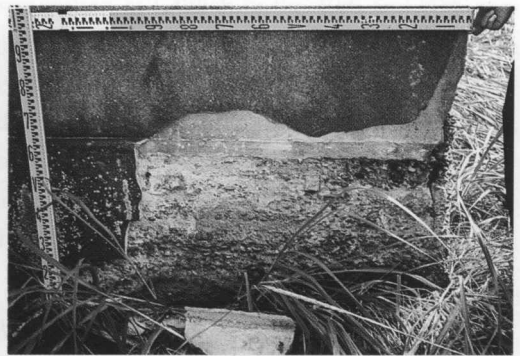
Photo. 28 Delamination of mortar progressing on exterior wall face at the west side
