# Study on damage of concrete structure and strength test of volcanic ash by Mt. Usu volcanic eruption.\*<sup>1</sup>

Hiroshi SAKURAI\*<sup>2</sup>, Kaneyoshi OKADA\*<sup>3</sup>

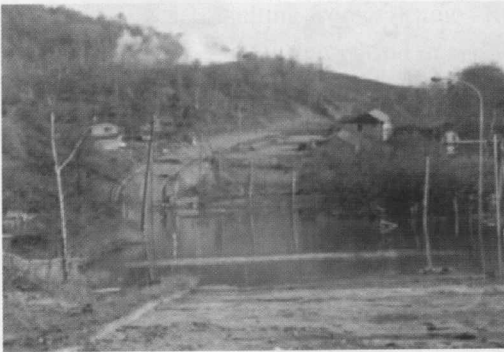
stones flying from the nearby Nishiyama volcanic crater south of Lake Toya hot spring. From south side of Lake Toya to Uchiura Bay neighborhood, many crustal fluctuation are visible this area. Volcanic craters formed along national highway route 230 shown in Photo 3.1.1.A. In the same area, the piers and foundations of bridges and other structures, including the drain shown in Photo. 3.1.1.B related to transportation and life-line infrastructure had risen up and been damaged. Bridge piers, roadbed, and tunnels along the Doou (Hokkaido Central) national expressway, the Muroran main line of JR Hokkaido Co. Ltd, Hokkaido prefecture roads, municipal roads etc. were damaged by crustal fluctuations as shown in Photo. 3.1.2. Example of pushing up, cracking, support failure are shown in Photo. 3.1.3.

Photo.3.1.1.A Volcanic craters formed and depression with water along national highway route 230 (Point D)

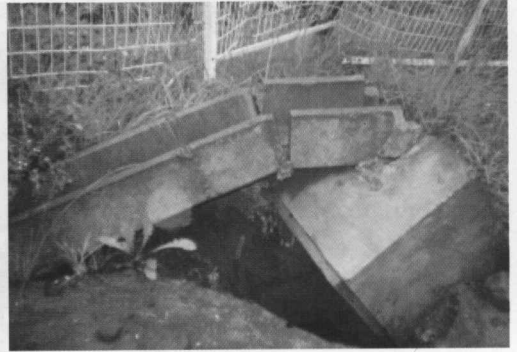
Photo.3.1.1.B Road drain damaged by crustal fluctuations of volcanic activity (Point A)

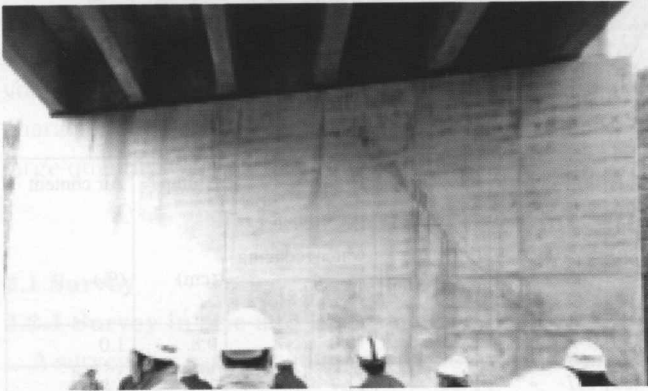
Photo.3.1.2 Bridge abutment damaged by crustal fluctuations of volcanic activity along Doou Expressway (Point B)

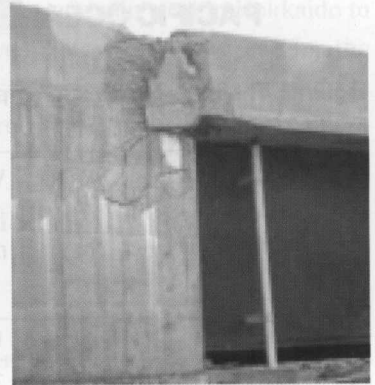
Photo.3.1.3 Cracking and support failure by crustal fluctuations of volcanic activity along Doou Expressway (Point B)

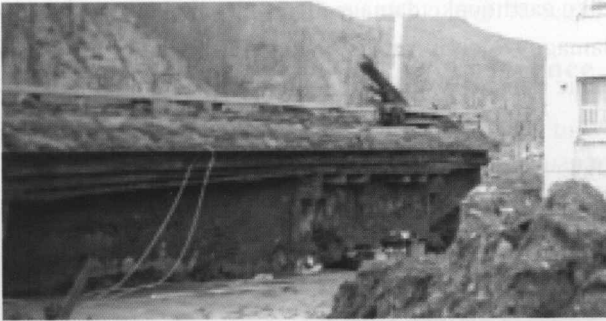
Structures on the shore of Lake Toya at north side of the Konpirayama crater were washed away volcanic ash mudflows. Especially intensive charge place is on the slope from nearby volcanic craters. Particularly serious damage was caused by volcanic ash mudflows to the national highway route 230 near Nishiyama river in Lake Toya hot spring resort. The RC beam of the Konomi bridge on national highway route 230 was washed away and pushed out by poured over volcanic ash mudflows from Nishiyama river, as shown in Photo. 3.1.4. And the bridge beam laid over on the several tens meters toward lower stream to Lake Toya.

Photo.3.1.4 RC beam road bridge on route 230 washed and pushed away by river poured over mud flow (Point C)

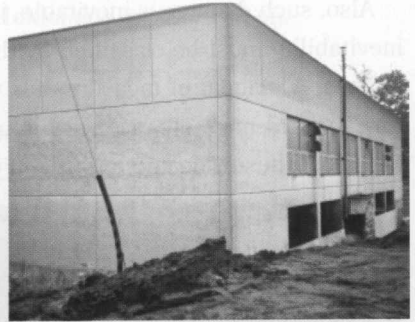
Pouring mud flows flowed into the 1F classroom of on the Toyako-onsen elementary school near river. The pouring mud flows were destroying window panes and frames. Also the Mizumi-dokusyono-ie of wooden-frame mortar structure used as community center by surrounding residents and children was completely destroyed, as shown in Photo 3.1.5.

Photo.3.1.5 First floor F classroom of elementary school damaged by river poured over mud flow (Point C)

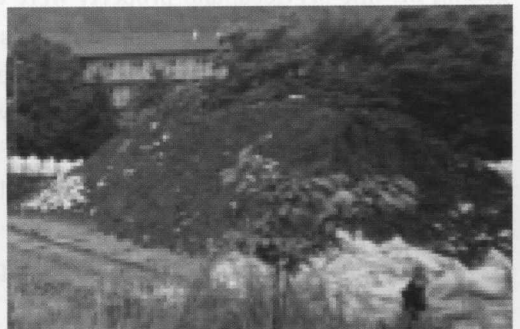
In order to use the volcanic ash for a resource as material of construction, the impurities in gathering volcanic ash are avoided to mix such as vegetable matter and garbage as shown in Photo. 3.2.1.

Photo.3.2.1 The volcanic ash of gathering site at the lakeside of the Lake Toya nearby Konpirayama volcano crater (Point C)

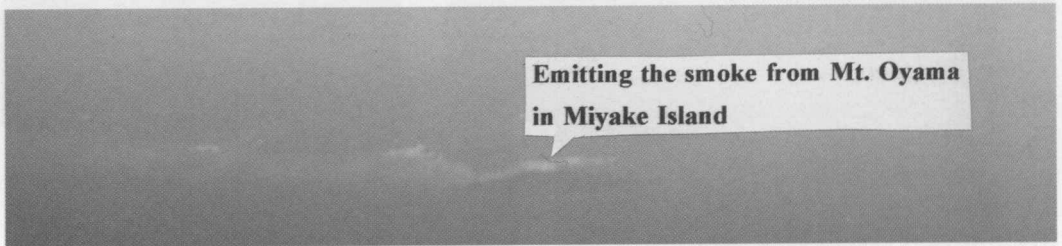
Volcanic activities are continuing to cause damage in this area and others, including Mt. Oyama in Miyake Island, as shown Photo. 3.3.1, in and elsewhere. Guards of mudflows must be maintained when the volcanic activity have stabilized like the case of Mt. Fugen in the Unzen mountain system as shown in Photo. 3.3.2.

Photo.3.3.1 Continuing volcanic activities and emitting the smoke with H<sub>2</sub>S from Mt. Oyama in Miyake Island.

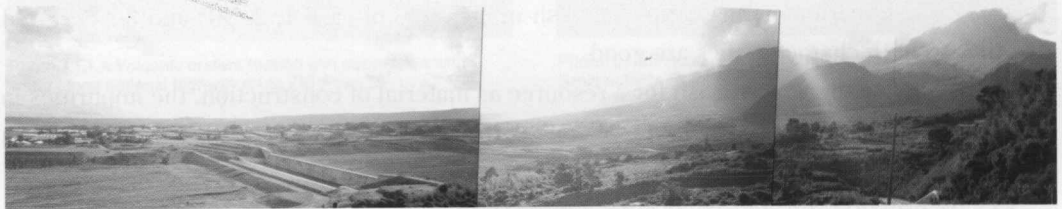
Photo.3.3.2 Guards of avalanche mudflows, sand and stone maintained at Mizunashi river of Mt. Fugen in the Unzen mountain system.
