2 A novel method of surveying submerged landslide ruins: Case study of the Nebukawa  
3 landslide in Japan

16 **Abstract**

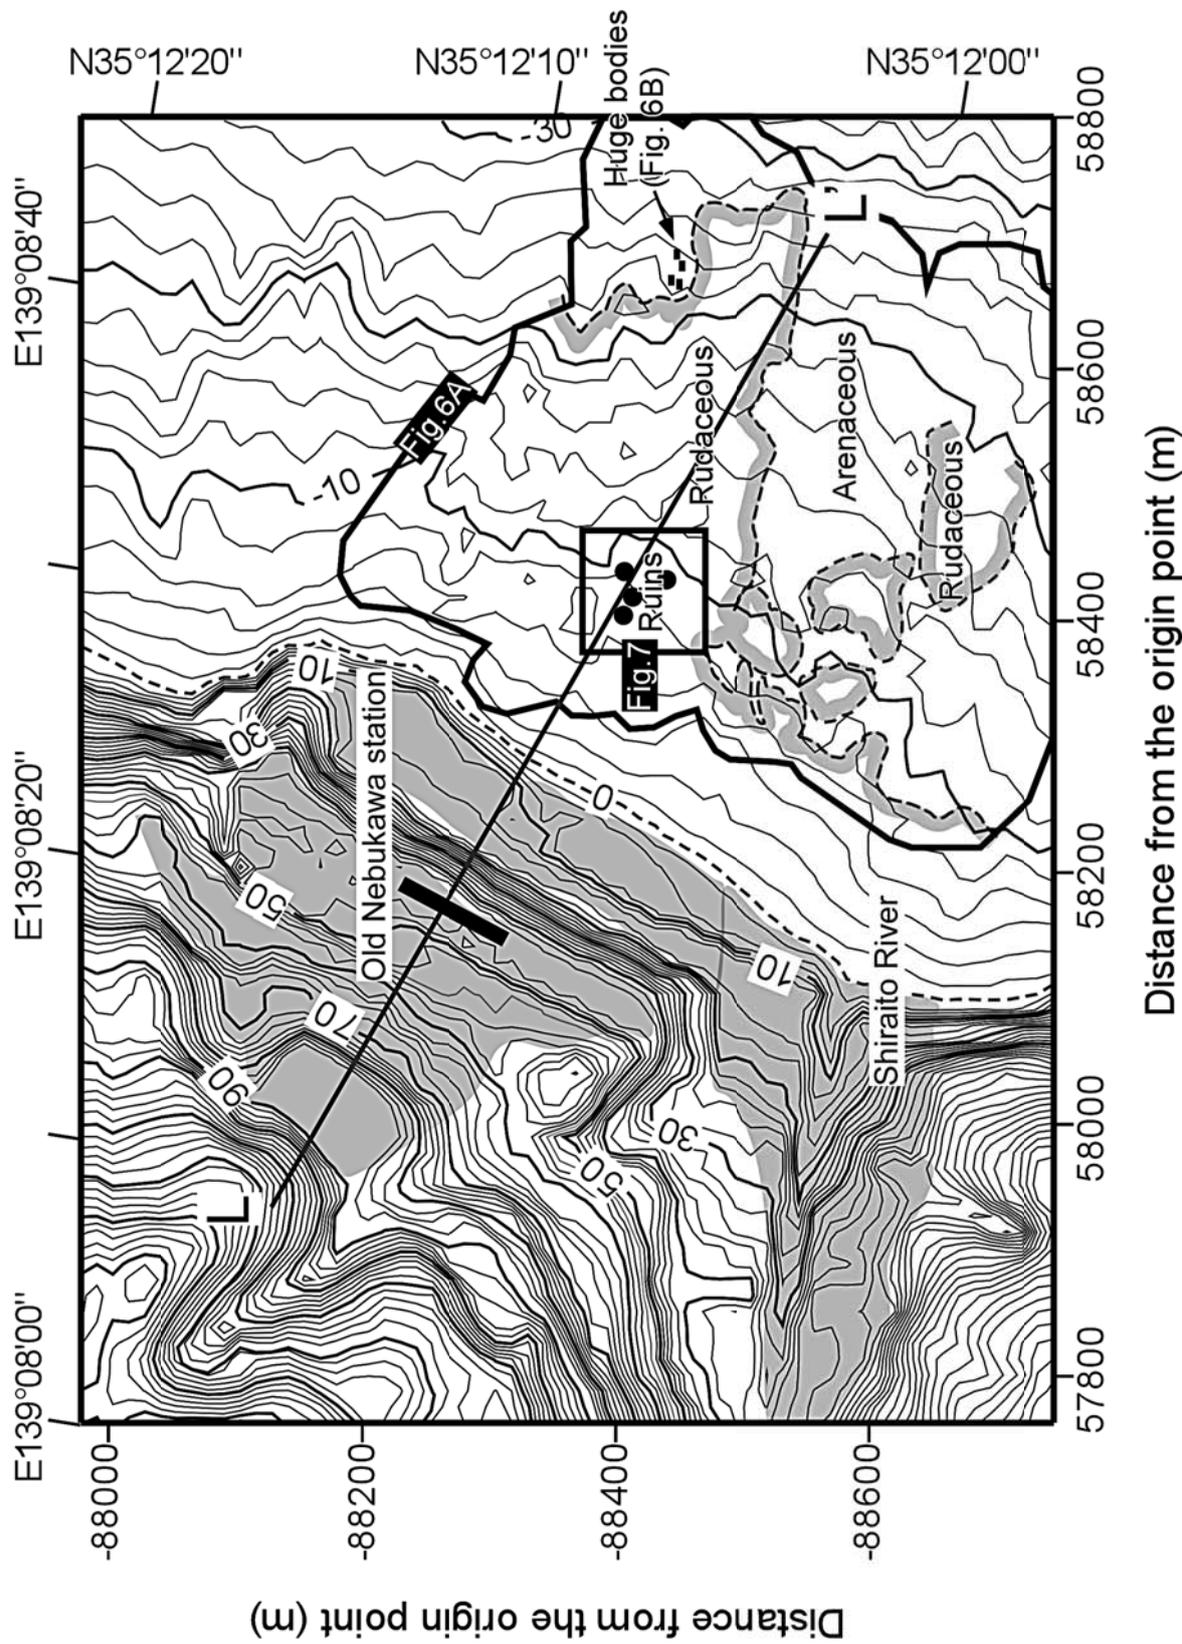
Fig.5

36 The bathymetric map we created is shown in Fig. 5. Small mounds, indicated

1 by closed contour lines, are situated in the water at depths of 6 m to 24 m offshore of the  
2 beach area buried by the 1923 Nebukawa landslide. The slope immediately offshore of  
3 the landslide area and the mouth of Shiraito River is relatively more gentle than it is  
4 farther offshore in the mapped area.

22 (A) Topographic and bathymetric map of the area shown in Fig. 1B (contour interval on  
23 land and under water, 2 m). The bold black line indicates the boundary of the side-scan  
24 sonar scanning area (Fig. 6A). The bathymetric map was generated from data obtained  
25 from this study. The topography on land was obtained from 5-m DEM data of the  
26 Geological Survey Institute of Japan.

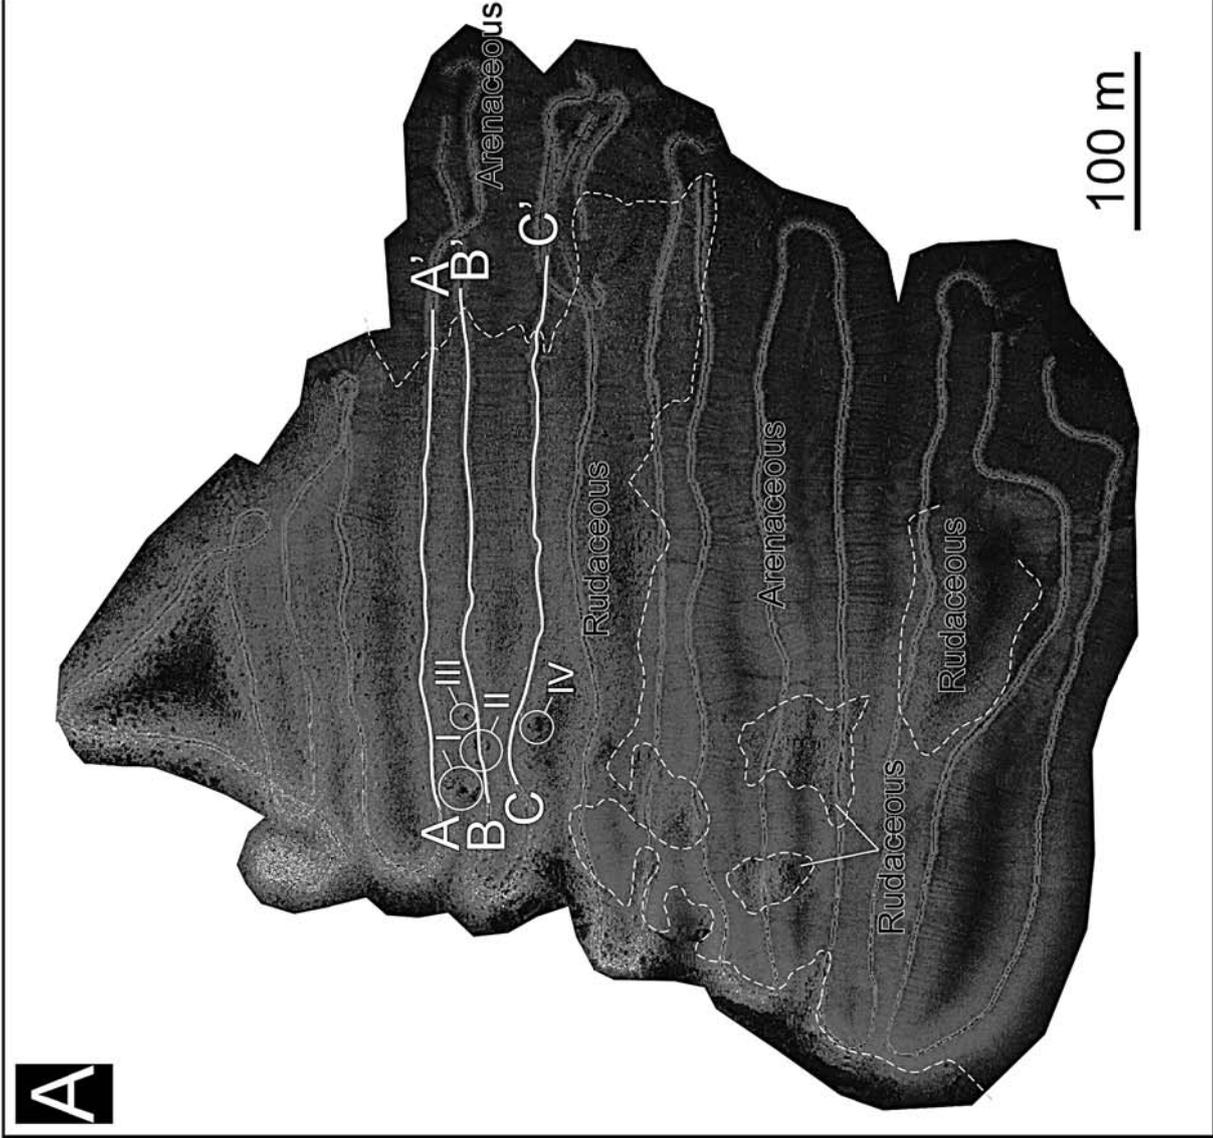
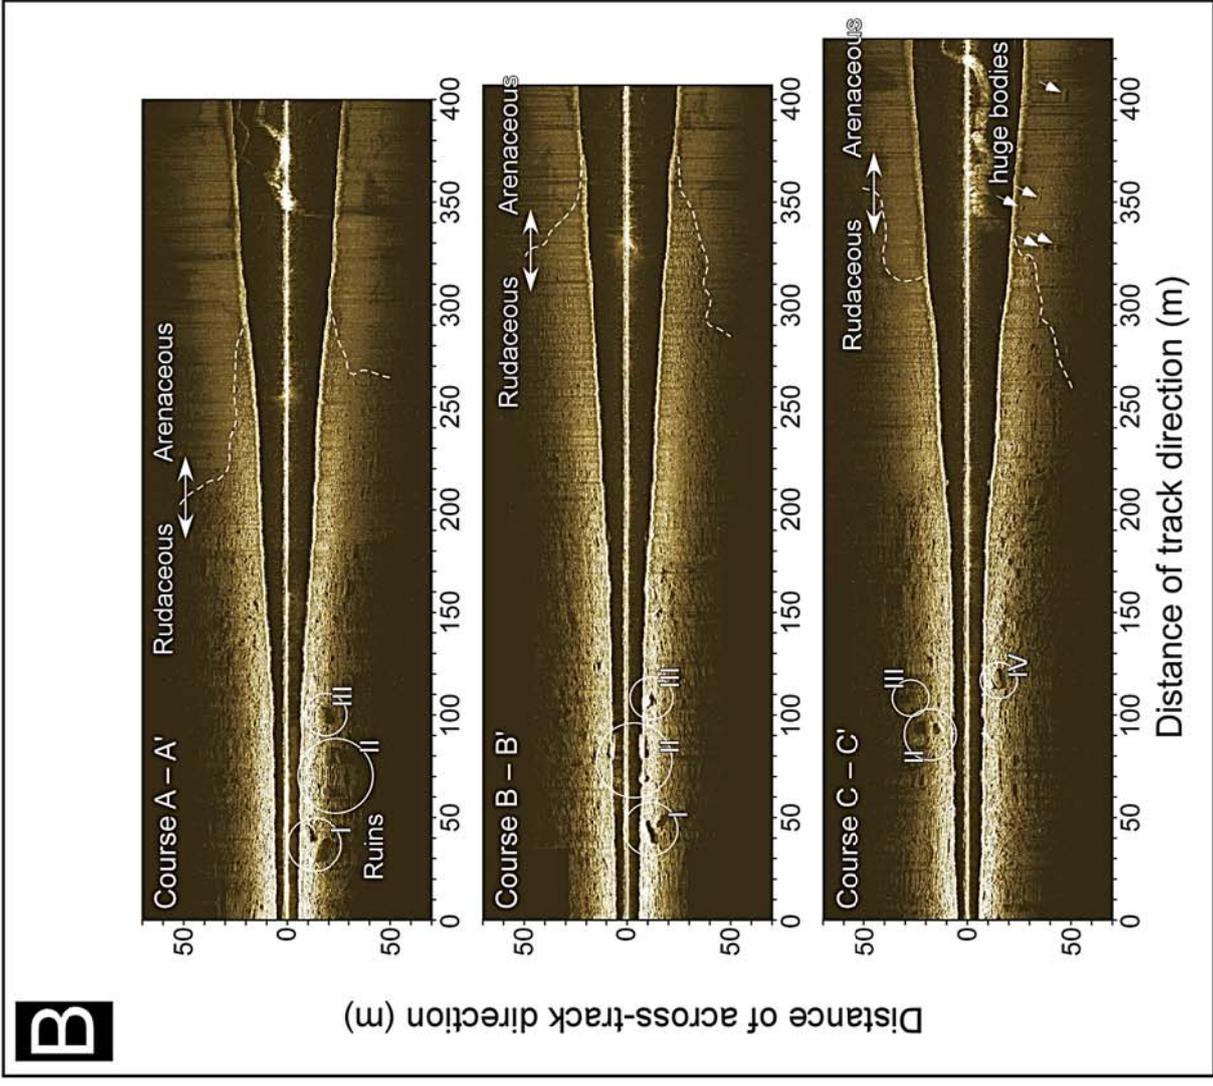
5 A synthetic side-scan image is shown in Fig. 6A. The bottom materials can be  
6 divided into two main types: rudaceous (large rock fragments) and arenaceous  
7 (sand-sized fragments). A rudaceous area spreads along the shoreline and extends  
8 tongue-like about 460 m offshore; its shape is irregular in the southern part of the  
9 mapped area. Three isolated rudaceous areas are also distributed offshore of the mouth  
10 of the Shiraito River.

11 The raw side-scan images show the composition of the bottom materials in  
12 more detail (Fig. 6B). The density of observable sized rocks (larger than several dozen  
13 centimeters) decreases with distance from the shore, but the boundary between  
14 rudaceous and arenaceous areas is clear. Although there is some image skew, some  
15 angular rocks appear in the rudaceous area. There are also some huge bodies (larger  
16 than several meters) in the deeper arenaceous areas (Fig. 6B, C–C').

1 a landslide in the area. The slope of the seafloor offshore of the area near the Nebukawa  
2 landslide is gentle. We infer that the mounds observed in this area were formed by the  
3 landslide because such mounds are often observed in areas where landslides have  
4 occurred. The ruins are situated on angular rock fragments (Fig. 8B) that lack rounding  
5 ablation; such fragments are usually made by mechanical fracturing during a landslide.  
6 The side-scan imaging showed angular rock fragments in the deeper parts of the  
7 rudaceous areas (Fig. 6B). Thus, the rudaceous areas were created by the landslide.

8 The size and shape of the Nebukawa landslide can be estimated from the  
9 bottom material data (Figs. 5 and 6). The rudaceous areas in Fig. 6 were made by the  
10 landslide, whereas the arenaceous areas were undisturbed by the landslide. The  
11 original arenaceous bottom was affected by sediment discharged from the Shiraito River  
12 before the 1923 Kanto earthquake. Sediment discharged from the river intensively  
13 affects the southern part of the rudaceous area, which has an irregular shape. In  
14 addition, when the 1923 Kanto earthquake occurred, debris also flowed from the river  
15 into the sea and covered the southern part of the Nebukawa landslide (i.e., the  
16 near-shore rudaceous area). The Nebukawa landslide may have spread farther south,  
17 but we could not confirm that using our methods. The distribution of the bottom  
18 materials indicates that the landslide mass traveled at least 460 m from the coast. Thus,

29 (A) Synthetic side-scan sonar images indicated in Fig. 5 and (B) selected raw side-scan  
30 images from offshore of Nebukawa. The Roman numbers refer to the groups shown in  
31 Fig. 7.

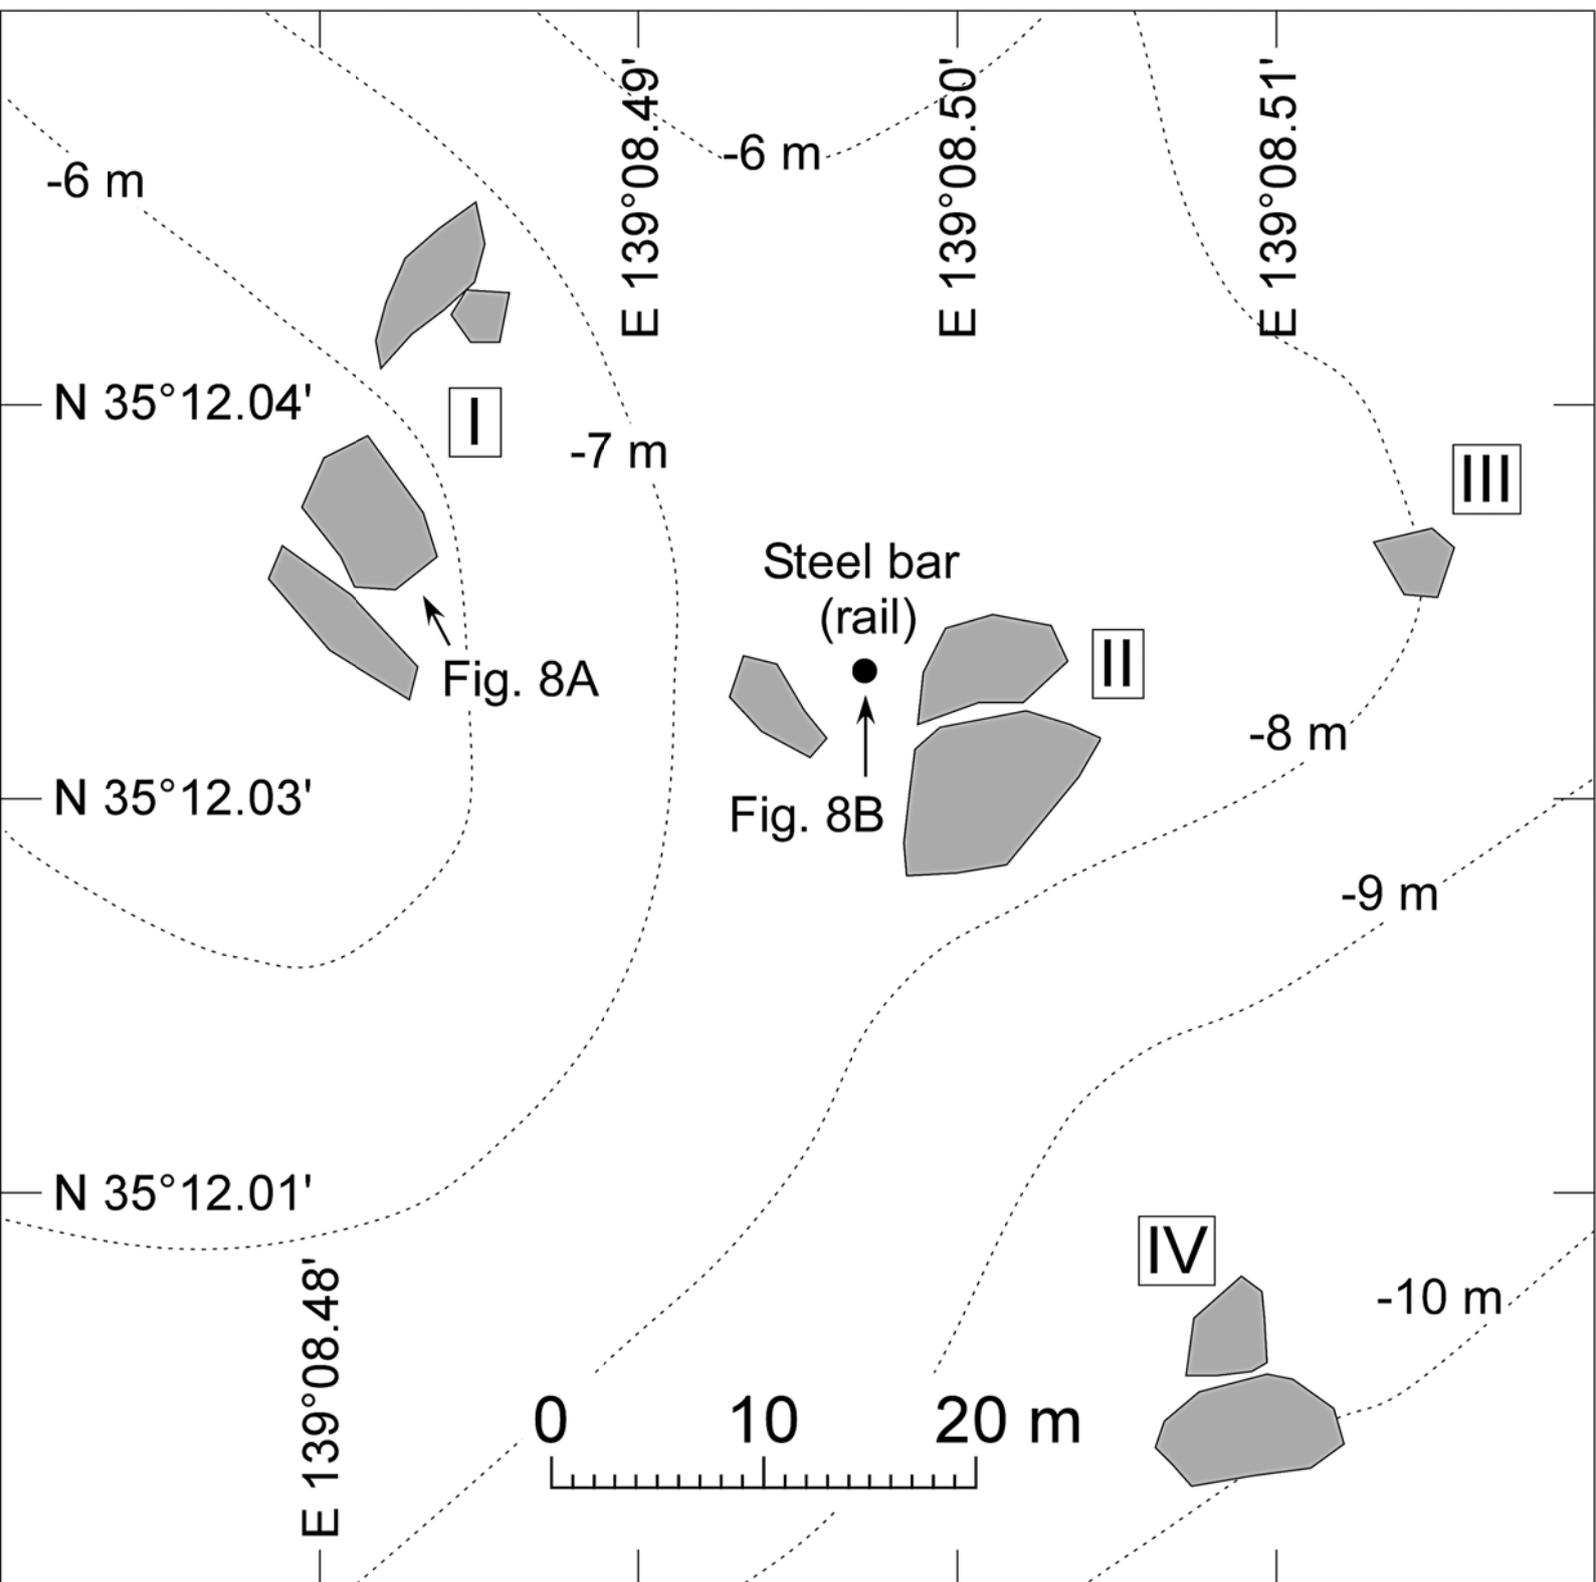
Fig. 7

19 The side-scan images suggest the presence of at least 10 prominent polygonal  
20 bodies at depths of 6 to 10 m on the rudaceous bottom (Fig. 7). These structures have  
21 been observed by divers and have been speculated to be submerged ruins from the  
22 landslide. These ruins can be divided into four groups by their distribution: group I  
23 consists of four angular bodies with maximum lengths of about 3, 10, 10, and 10 m;  
24 group II consists of three angular bodies, about 6, 8, and 11 m long; group III consists of  
25 one angular body about 5 m long; and group IV consists of two angular bodies, with  
26 lengths of 5 and 11 m.

33 **Fig. 7**

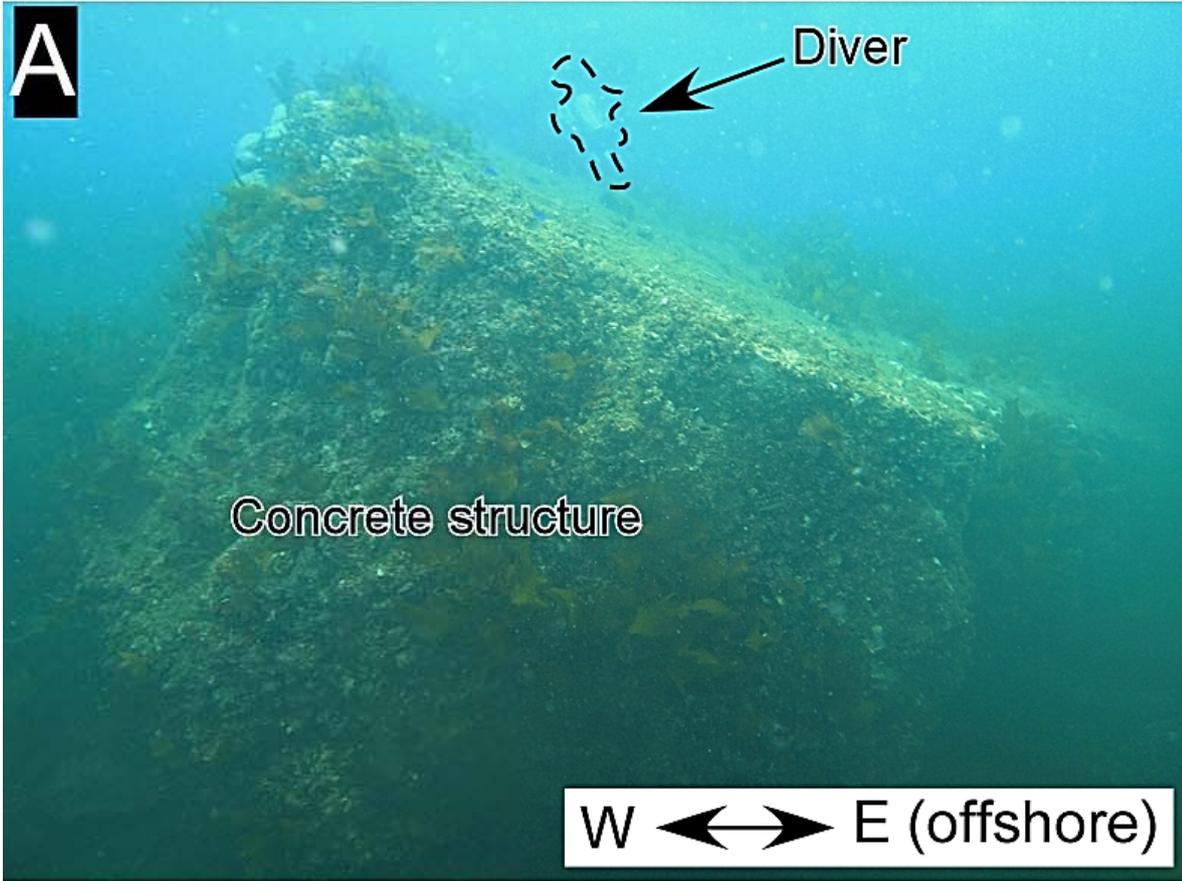
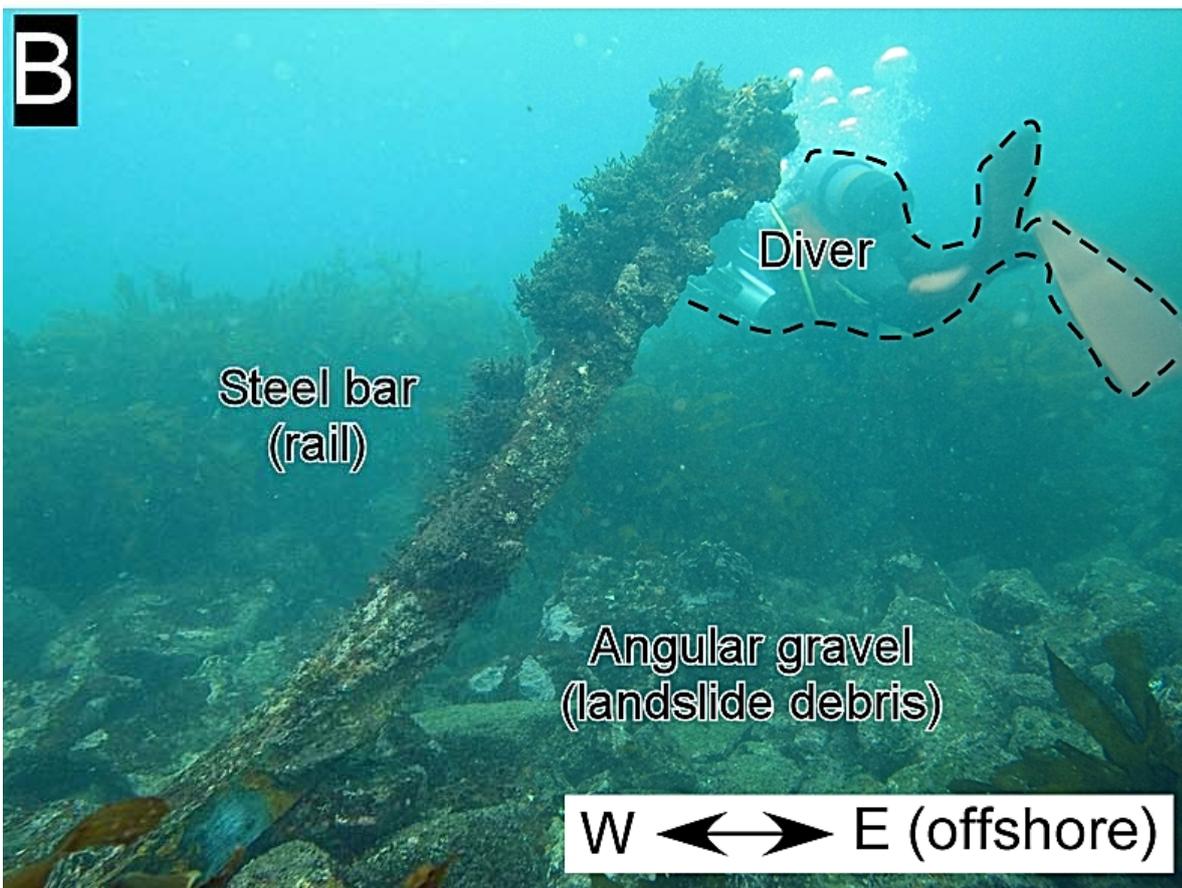
# Fig. 8

27 After the acoustic survey, we conducted a diving investigation near groups I  
28 and II, and confirmed that the largest angular structure was made of concrete (Fig. 8A).  
29 We also observed a steel bar resembling a rail near group II (Fig. 8B). The ruins of  
30 groups III and IV were similar in shape and size to the large bodies in groups I and II.  
31 The ruins are directly situated on angular rock fragments that had no rounding  
32 ablation (Fig. 8B).

- 1 Fig. 8
- 2 Underwater photographs of a concrete structure in group II, and of a nearby steel bar.
