# Investigation of damage caused by recent large earthquakes and earthquake-proofing in Japan and the USA\*<sup>1</sup>

## Abstract

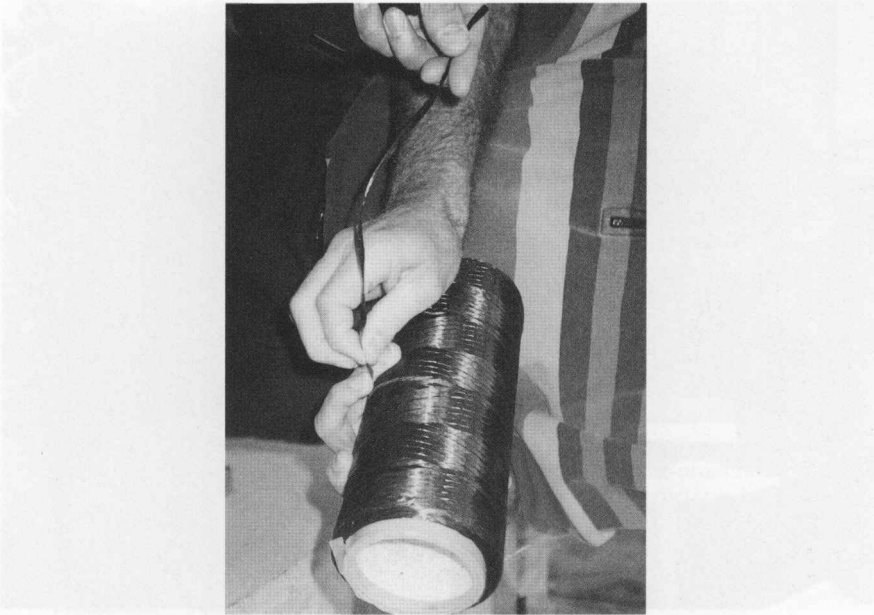
Photo 6 Carbon fiber material

Carbon is applied to bridge columns as a composite carbon shell system (Photos 4 and 5). The carbon shell system represents an innovative and cost-effective approach to bridge column design by taking advantage of the excellent mechanical properties of an advanced composite material, automated manufacturing processes, and fast field implementation [4] (Photos 6, 7, 8, and 9).

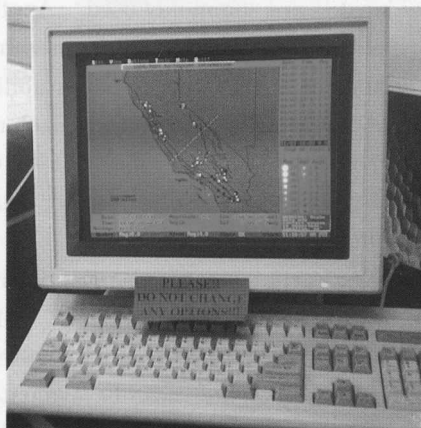
**Photo 15** Setting points of accelerometer and the earthquake observation system (CUBE) in CALTECH

The period 1989 to 1995 has seen a series of large, record-breaking earthquakes in Japan and the USA, including inland earthquakes in urban areas and ranging in magnitude from 6.7 to 8.2. These days, many important locations are monitored with accelerometers for research into earthquake-proofing, so large peak ground accelerations were recorded near the epicenter of some of these earthquakes and in areas suffering severe damage (Photo 15).

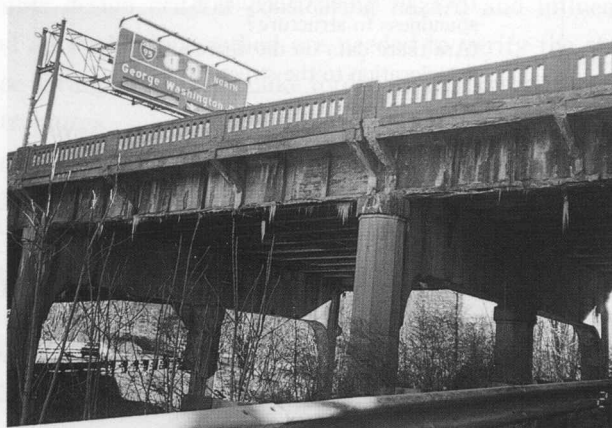
**Photo 16** Stationary effects of the deterioration by external factor and internal factor to concrete structure in service year

Concrete structures have to withstand the non-stationary effects of external forces such as earthquakes, wind, and so on, as well as the stationary effects of the deterioration of external factor and internal factor. Though the stationary effects of deterioration have recently been a lively area of study [15], the safety of deteriorated structures during earthquakes in its service has not been studied. However, examinations which include durability and earthquake-proofing are essential for the proper and safe maintenance and management of concrete structures. A procedure for evaluating both deterioration and earthquake-proofing, and the problems with such an evaluation, are considered in this section.
