# Study on durability evaluation of concrete structure constructed over 60 years ago in cold region\*<sup>1</sup>

## Abstract

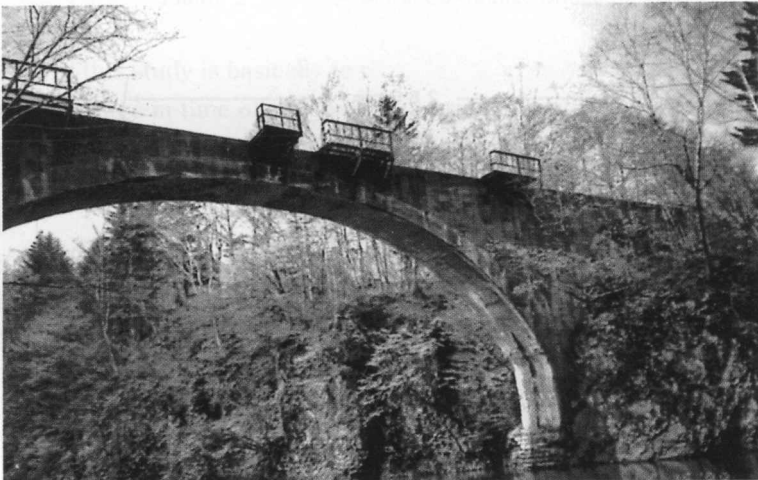
Deterioration at the edge of member was remarkable caused by frost damage. Especially damaged are the sides exposed to sunshine and the parts of surface where rain and melt-water ran because of inadequate drainage from rail ground surface. Occurrence of efflorescence was remarkable at placing joint of arch and crack of the side. There is a little scour of the foundation at Tokachi Mitsumata side (Photo-3, 4 and 5).

**Photo. 3** The shape of Dai San Otofuke Bridge from river side and a little scour of the pier foundation at Tokachi Mitsumata side (under 3P from Obihiro side)

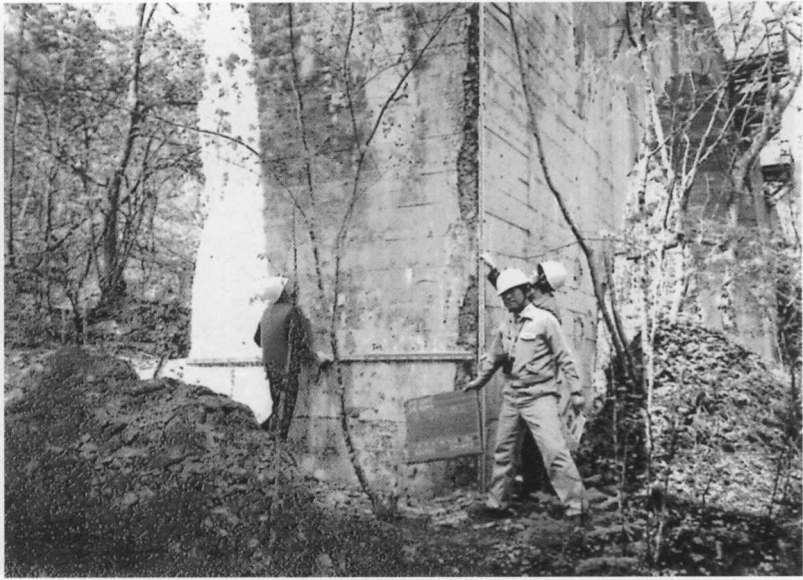
**Photo. 4** Deterioration and scaling at the edge of member caused by frost damage on 2P from Obihiro side of Dai San Otofuke Bridge

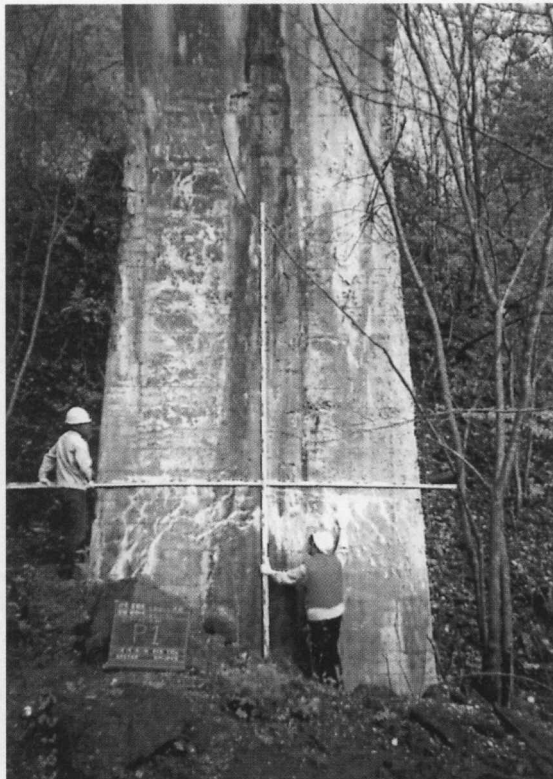
**Photo. 5** The surface of bridge pier (1P from Obihiro side) for non-destructive test of Dai San Otofuke Bridge

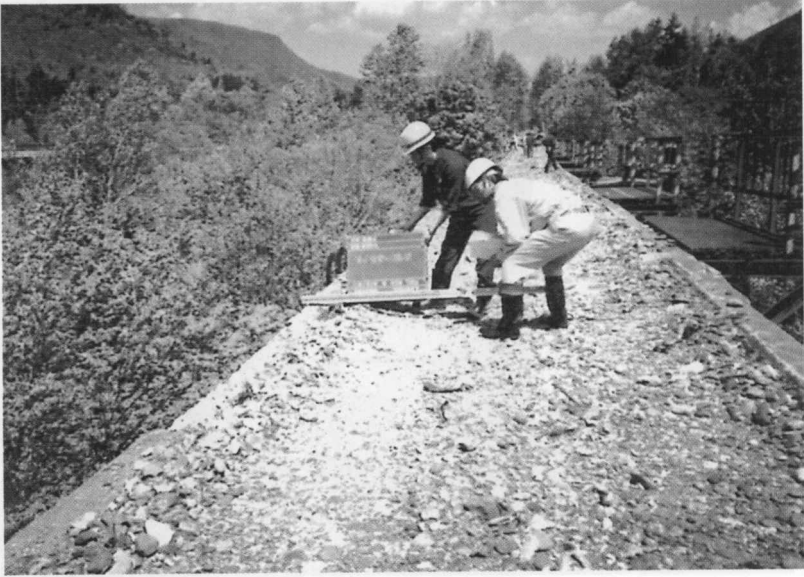
The deterioration level of Dai Go Otohuke Bridge is more remarkable than Dai San Otohuke Bridge (Photo-6, 7 and 8).

**Photo. 6** A complete view of deck of Dai Go Otofuke Bridge from Obihiro side and the edge of deck is deteriorated.

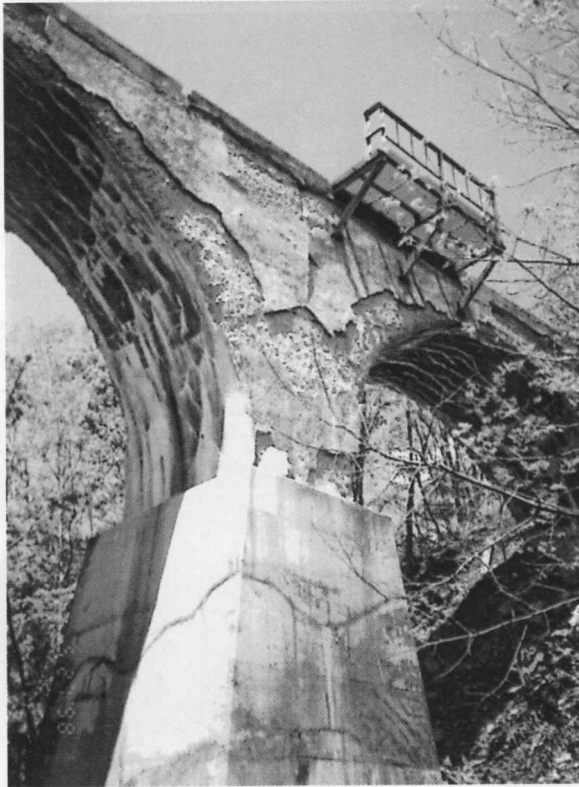
**Photo. 7** Deterioration and crack at a part of repair on 1P from Tokachi Mitsumata of Dai Go Otofuke Bridge

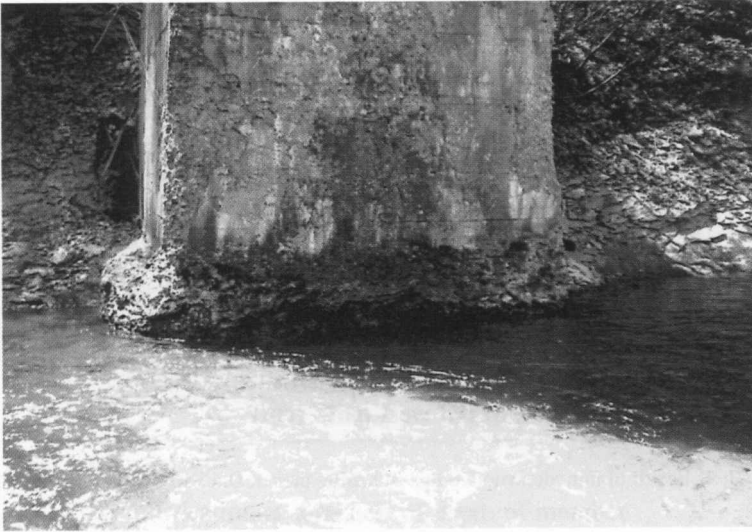
**Photo. 8** Scour of the foundation at Obihiro side (1P from Obihiro side) of Dai Go Otofuke Bridge

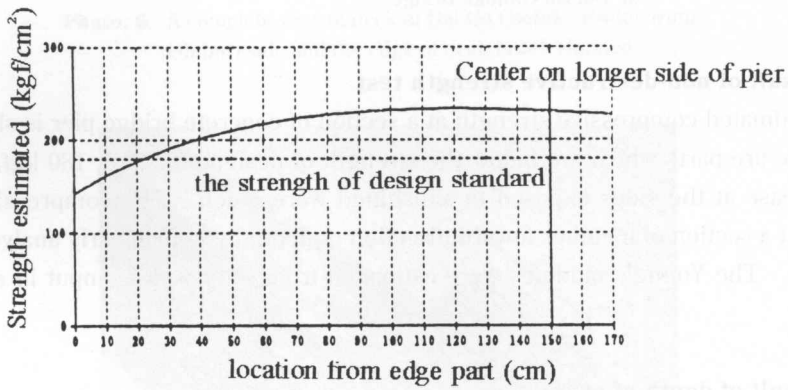
The estimated compressive strength at a section of concrete bridge pier is shown in Fig. 3. 1. There are parts which are below the strength of design standard, 180 kgf/cm<sup>2</sup>. Especially decrease at the sides exposed to sunshined were much. The compressive strength estimated at a section of member toward direction of depth by non-linearly analysis is shown in Fig. 3. 2. The Young's modules were estimated from the result to input in analyzing by FEM.

Fig. 3. 2 Strength estimated by non-linearly analysis

bridge pier have not suffered frost damage by several freeze-thaw cycles, because the parts were frozen during a winter season[1]. As shown in Fig. 3. 2, the decrease of strength on part at a depth of more than 35 cm from the surface is less than the surface which had deteriorated severely. If water rarely penetrate, the decrease of strength in the inner part is of very low level.
