# Development of a meandering channel caused by the planform shape of the river bank

T. Nagata<sup>1</sup>, Y. Watanabe<sup>2</sup>, H. Yasuda<sup>3</sup>, and A. Ito<sup>1</sup>

<sup>1</sup>Civil Engineering Research Institute for Cold Region, Public Works Research Institute, Japan

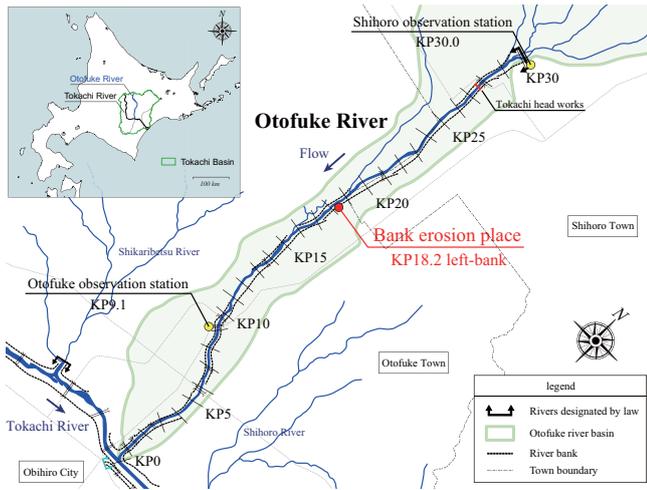
Figure 1. Bank disaster area (Otofuke River, Hokkaido, Japan).

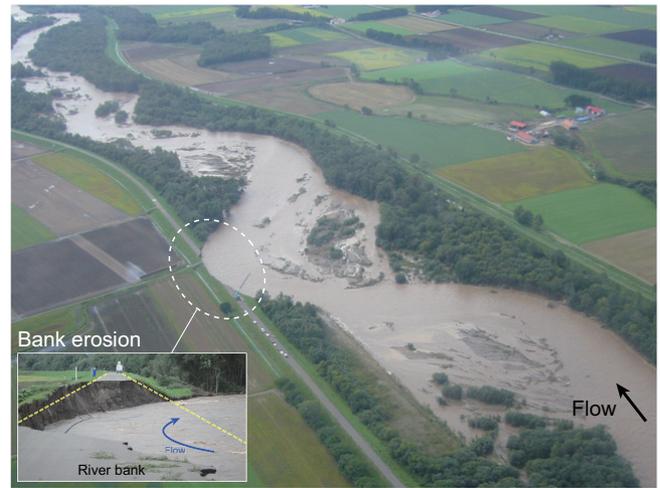
Figure 2. Situation at the time of bank disaster (7 Sep. 2011).

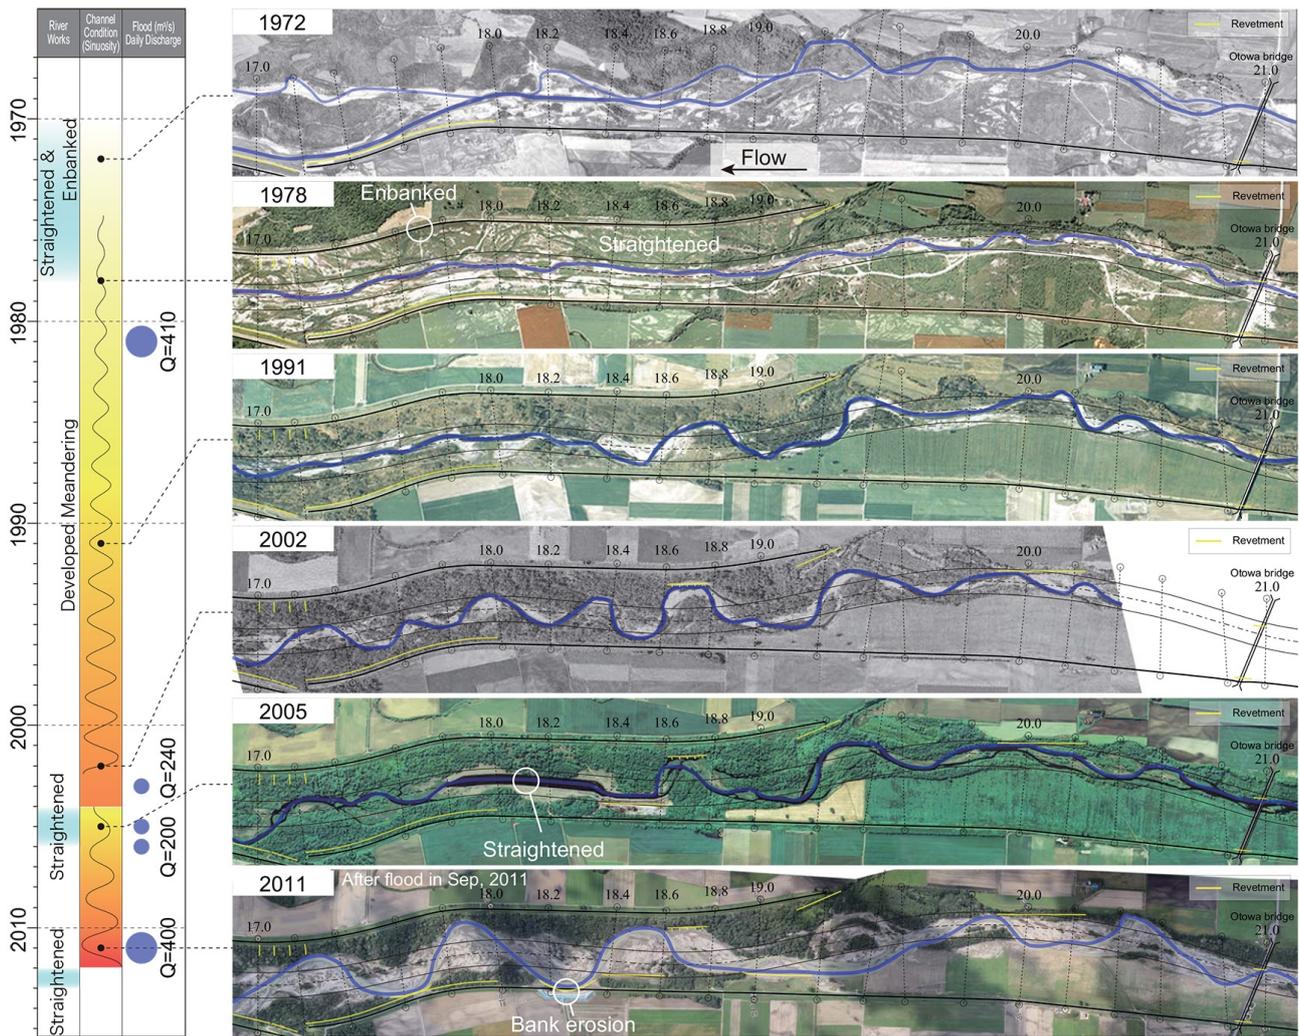
Figure 3. Migration history of the river channel (Otofuke River, KP17.0–KP21.0).

To estimate the factors that brought about the bank disaster, the river channel formation process was investigated in the section extending from KP17.0 to KP21.0, which includes the damaged location. The aerial photos in Fig. 3 indicate the typical changes that took place in the river channel during the roughly 30 year period from the late 1970s to the post-flood time. The chronological table (on the left) shows river improvement work, which is an unnatural external force; major floods, which are a nature-derived external force; and an image of the meandering channel that developed as a result of those forces. In this section, large-scale river work was performed in the 1970s to straighten the low-water channel, and this period is marked as a starting point of the river channel formation that has been continuing up to the present. After that, the largest recorded flood took place, in 1981, and it triggered the further development of meandering channels.

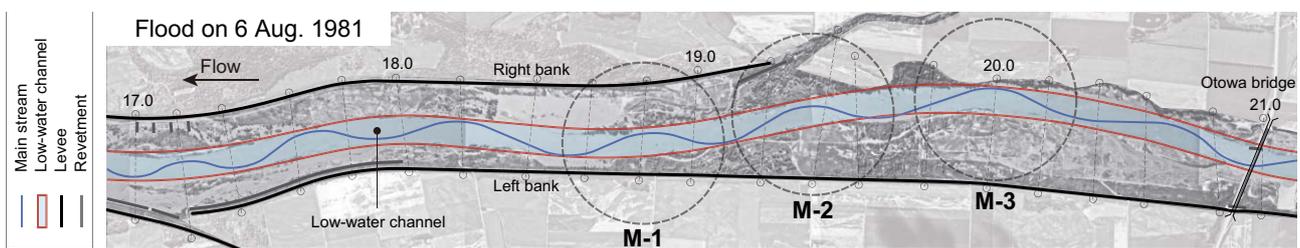
Figure 4. Main streamline and front bank line of the low-water channel during the 1981 flood (recession period).

Figure 4 shows the flow regime of the period when discharge decreased during the 1981 flood. The red line represents the riverbank of the low-water channel along the normal line of river channel, and the blue line represents the main streamline. At this point, three large meandering parts had already formed in the upstream section (KP18.4–KP21.0), and as shown in Fig. 3, these flows (hereinafter: M-1, M-2 and M-3 from downstream to upstream) gradually increased the degree of meandering over the period of 30 years.

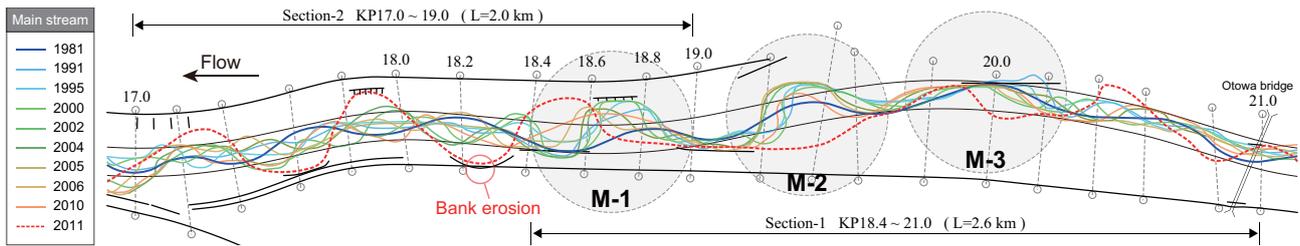
Figure 5. Changes in the configuration of meandering channels (1981–2011, KP17.0–KP21.0).

Figure 5 diagrams the horizontal curve of the main stream-line from the aerial photos taken in 10 different years over the past 30 years. The changes from 1981 to 2010 show that the watercourse shifted repeatedly and irregularly toward the left and right banks immediately downstream of KP18.6. In contrast, M-1, M-2 and M-3, which are on the upstream side of KP18.6, shifted their phase slightly downstreamward, while shifting their waveforms forward. Also, M-1, M-2 and M-3 increased the degree of meandering in a single direction; however, the sandbar remained at an almost fixed position. Thus, the upstream side shows changes that are obviously different from those of the downstream side.

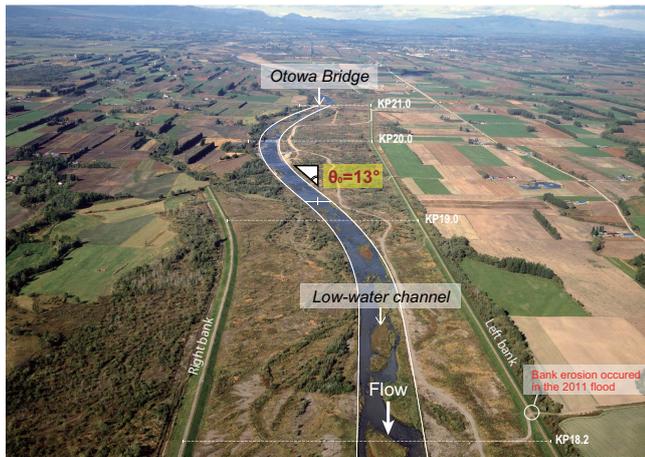
Figure 6. Planform shape of the low-water channel in 1978.

As the initial condition of the river channel in Section-1, the channel configuration after the river was channelized into a straighter channel with only low-amplitude curvature (Fig. 6: before the 1981 flood) and was simplified as follows. In the planform shape of the low-water channel, the normal line in the low-water channel was approximated by the sine-generated-curve shown in Fig. 7, and the low-water channel represented by the red line in Fig. 5 was designed to be a meandering channel with a meandering angle  $\theta_0$  of  $13^\circ$  and river width of 100 m. On the basis of previous survey data, the cross-section profile of the low-water channel was designed to have a 2 m-high bank with a slope gradient of 2 : 1, and the riverbed surface was designed to give particle-sized disturbance to the flat bed. The left and right sides of the low-water channel were provided with a 100 m-wide flood-plain that allows bank erosion, and the entire calculation area was a movable riverbed. A longitudinal slope of 0.00610 was used, which was the average value for Section-1.

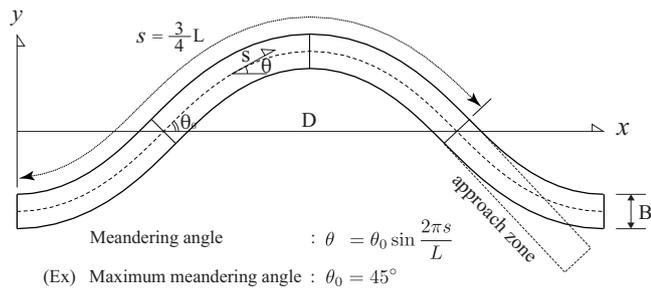
Figure 7. Definition of the sine-generated curve.

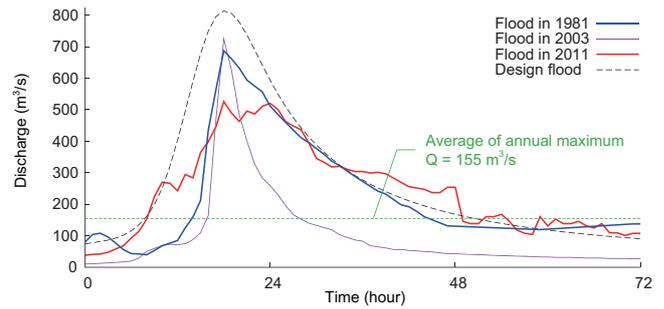
Figure 8. Discharge hydrographs of the major floods.

Figure 8 compares discharge hydrographs of previous major floods. The results of the analysis for Section-1 make it possible to understand the characteristics of bed morphology formed by the 1981 flood, in addition to how the riverbed responded to the steady flow. The figure shows that the discharge of the 1981 flood had a scale comparable to the design-flood discharge. In addition, the 2011 flood fell below the 1981 flood in terms of discharge during peak discharge; however, the 2011 flood exceeded the 1981 flood in terms of the duration of the average annual maximum discharge.

Next, riverbed elevations were compared after discharge with the same flow rate as that of the 1981 flood was introduced for 3 days (red line in Fig. 8), which is shown in the plan view of the riverbed elevations in Fig. 11. In the figure, the blue dotted line represents the configuration of the main stream in the recession period of the 1981 flood (blue line in Fig. 4), and the red line represents the configuration of the main stream during the low-water discharge in 1991. The analysis results show that three meandering parts (M-1, M-2 and M-3) that had wavelengths of approximately 600 m formed at regular intervals in the 1.8 km-long section. Comparison between the configuration of the flow channels shown in calculation results and those in 1981 or 1991 shows that the locations and intervals of the meandering channels are roughly in accordance with those in 1981 or 1991.

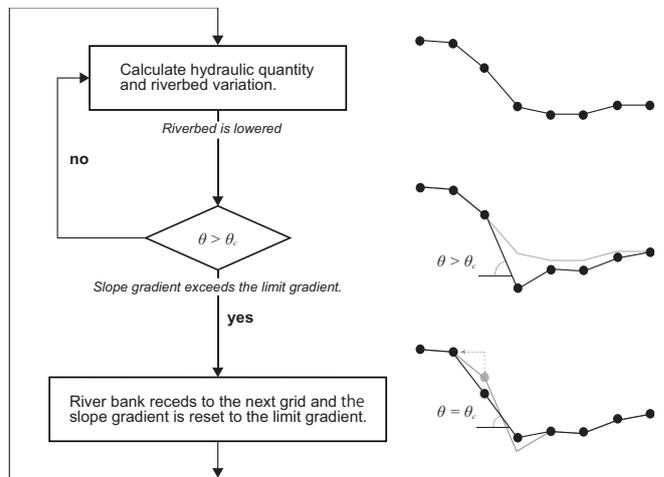
Figure 9. Slope failure model (refer to Nays2D solver manual).

Furthermore, in the present study, a slope failure model was used to reproduce the bank erosion phenomenon (Fig. 9). This model is designed such that the low-water riverbank is simulated to collapse naturally when the slope gradient exceeds a certain limit; thus, the bank erosion phenomenon is reproduced indirectly by moving the riverbank backward to maintain the limiting gradient; at which time the sediment budget is balanced by backfilling the lower part of the riverbed with the collapsed sediment. Since the present model is not intended to physically solve for bank erosion phenomena, there still remains the challenge that the results of the analysis depend on the choice of computational grid; however, previous studies have proved that the development of meandering flow is able to be reproduced to a certain degree. In this analysis, the limiting gradient of the slope is set as  $\theta_c = 25^\circ$ . Additionally, in all the simulations in this study, uniform flow depth was given as a boundary condition at the downstream edge of the analysis section and sediment budget at the upstream edge was assumed to maintain a state of equilibrium.

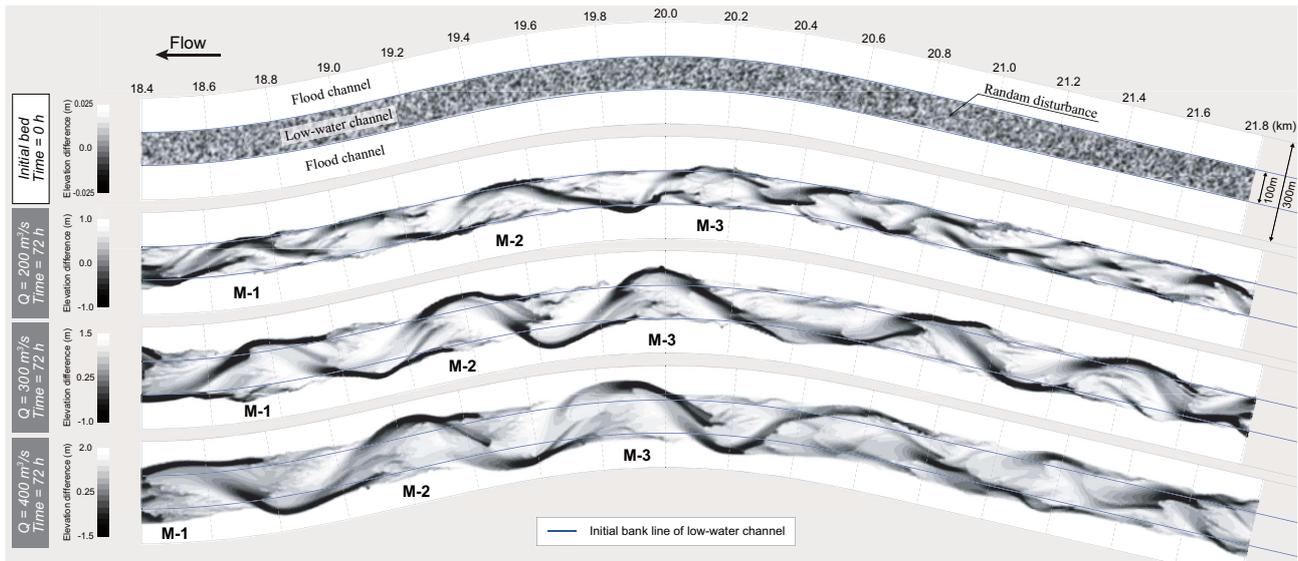
Figure 10. Analysis results of steady flow in Section-1 (riverbed elevation).

Riverbed elevations after 3 days of steady flow are compared in the plan view of the riverbed elevations in Fig. 10. The figure shows the elevation differences of the riverbeds as compared by using a constant bed slope of 0.00610. Hereafter, elevation differences are compared in the same manner.

The results shown in the figure suggest that discharge of  $300 \text{ m}^3 \text{ s}^{-1}$  had a dominant influence on the development of the meandering flows. Moreover, what should be noted here is that the locations of the meandering channels (point bars) formed on the downstream side of the bend of the river channel and at intervals between them. Wavelengths slightly varied depending on the scale of discharge; however, the meandering channels that have wavelengths of approximately 600 m, formed at almost regular intervals. These meandering

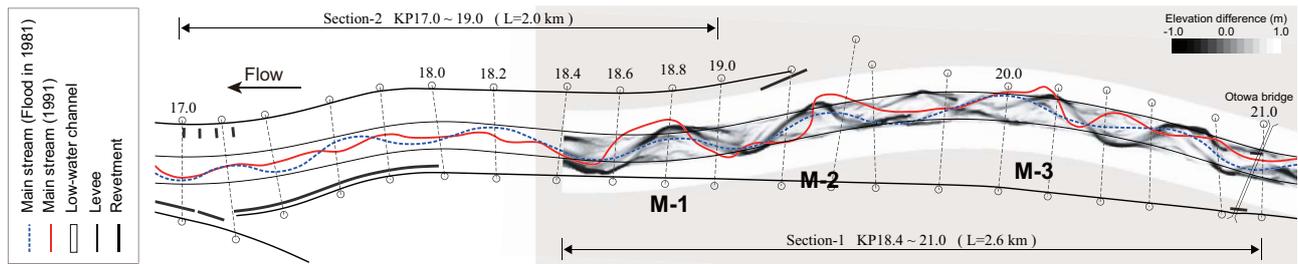
Figure 11. Analysis results of the 1981 flood in Section-1 (riverbed elevation).

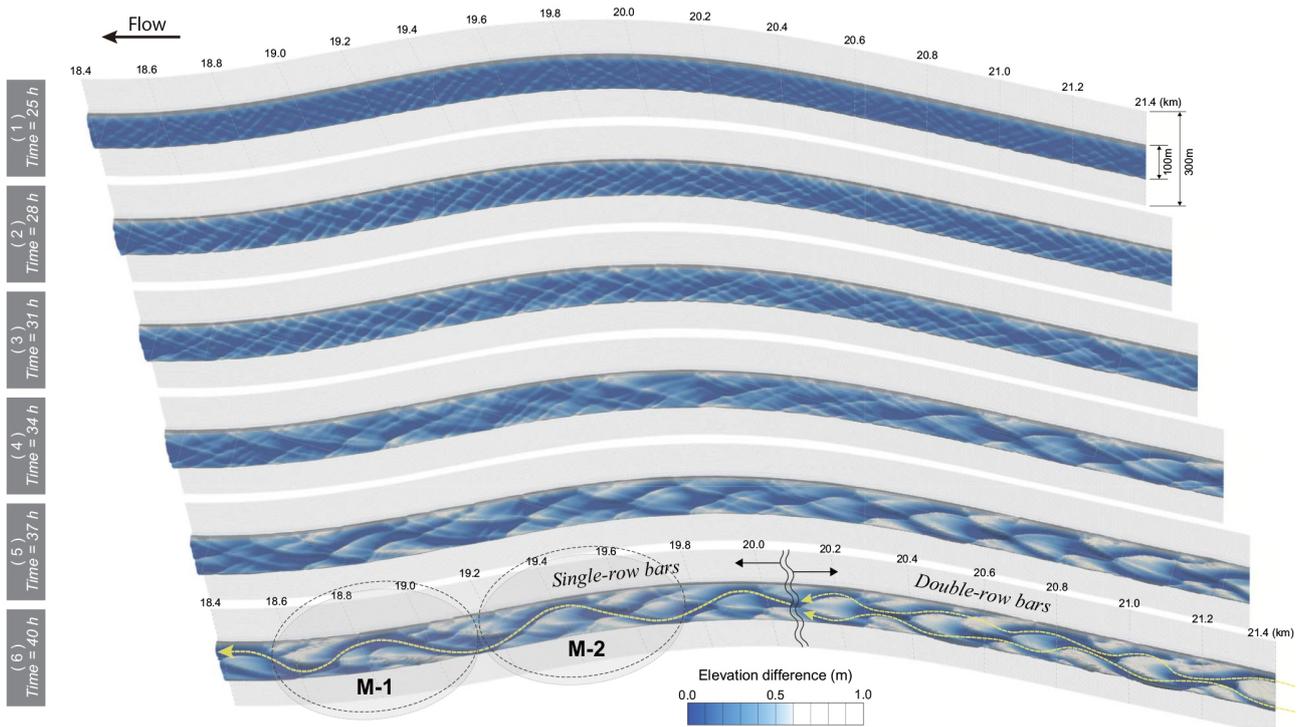
Figure 12. River channel formation process after peak discharge (1981 flood, KP18.4–KP21.4, Section-1).

Factors that led to the formation of the above-mentioned sandbars will be discussed on the basis of the transition process of bed morphology during the flood. Figure 12 shows the calculated river channel formation during the period when discharge was lower in the 1981 flood, and the displayed time of each result corresponds to each displayed time of from (1) to (6) in Fig. 13. The transition process of bed morphology during the flood can be roughly described as follows: a sign of change started to appear on the surface of the riverbed after the peak discharge, and then multiple-row bars on the riverbeds changed into double-row bars over time. For the time period from (5) to (6), differences in bed morphology are found between the section immediately upstream of the bend and the section immediately downstream of the bend in the river channel. While double-row bars still remain in the upstream section, the trend toward the development of single-row bars is already clearly seen in the downstream section. This is probably because the downstreamward migration of the sandbar was limited at the bend in the river channel, which provided conditions better than a straight river channel for the development of sandbars, and the developed sandbars eventually completely stopped moving, which then promoted the development of single-row bars. However, it is unknown whether such a phenomenon was taking place in the actual river. But in calculation, it describes the spin-up process in the numerical model as the flow transitions

Further, it was observed in this analysis that sandbars in M-1, which formed immediately downstream of the bend, eventually triggered the development of sandbars in M-2 on the upstream side, and those sandbars then gradually increased the degree of meandering. That is, it is considered that, since point bars that form in the bend area of the river channel can even limit the migration of sandbars on the upstream side, the impact from those point bars will spread further upstream indirectly.

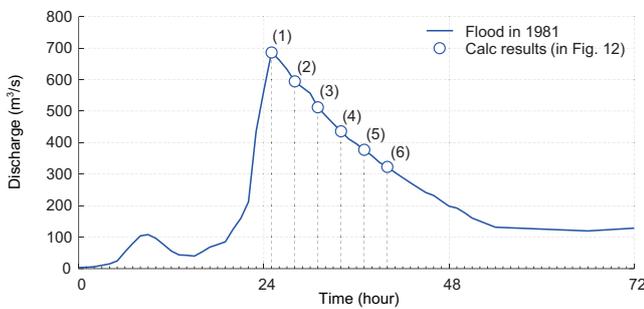
Figure 13. Display time of calculation results (1981 flood).

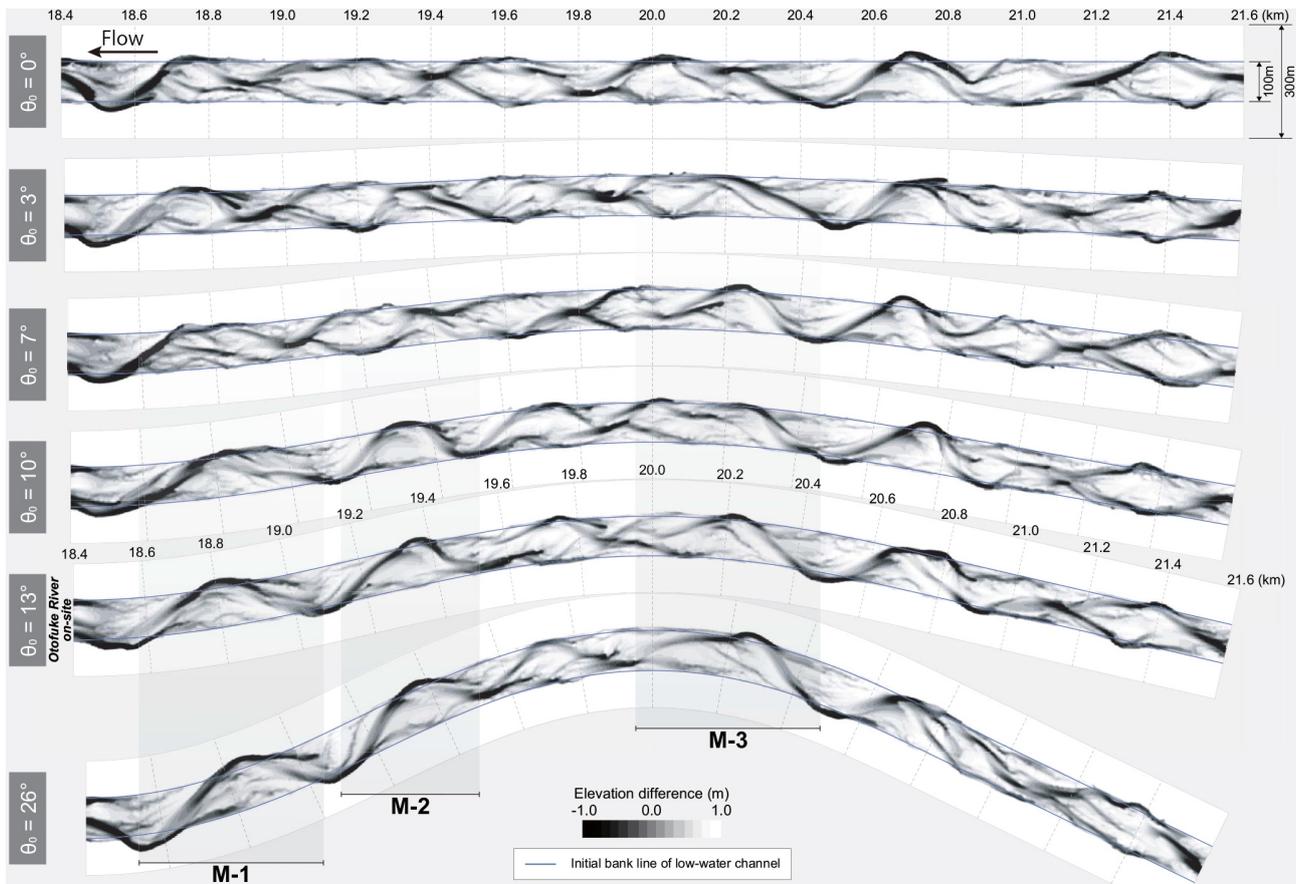
Figure 14. Development of meandering channels at various meandering angles (1981 flood, KP18.4–KP21.6).

Some examples of the calculation results are shown in Fig. 14. Additionally, as shown in Fig. 15, this calculation condition can allow the trend toward the development of single-row bars even in a straight channel (meandering angle  $\theta_0 = 0^\circ$ ), because single-row bars can develop even in a straight channel around the peak discharge. Therefore, it is difficult to extract only the influence that the curvature of the river channel has on the development of single-row bars; however, it is possible to evaluate the influence of the difference in meandering angle on the development of meandering channels to some degree by comparing the development of meandering channels using the river channel configurations with the meandering angle of  $\theta_0 = 0^\circ$  as a benchmark.

Figure 14 shows the general trend in which the riverbed configurations become double-row bars with decreases in

meandering angle, and in which the trend toward the development of single-row bars is observed to become clearer with increases in the meandering angle. In particular, in the meanders, M-1, M-2 and M-3, which are the colored parts in the figure, comparatively sharply defined point bars were formed when the meandering angle was around  $\theta_0 = 10^\circ$  or more.

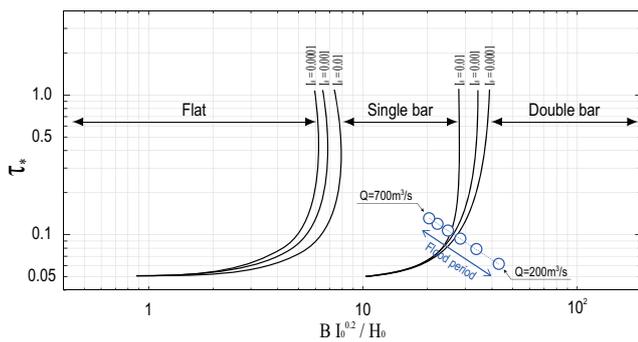
Figure 15. Mesoscale bed morphology classification (e.g., Kuroki and Kishi, 1983) during the 1981 flood.

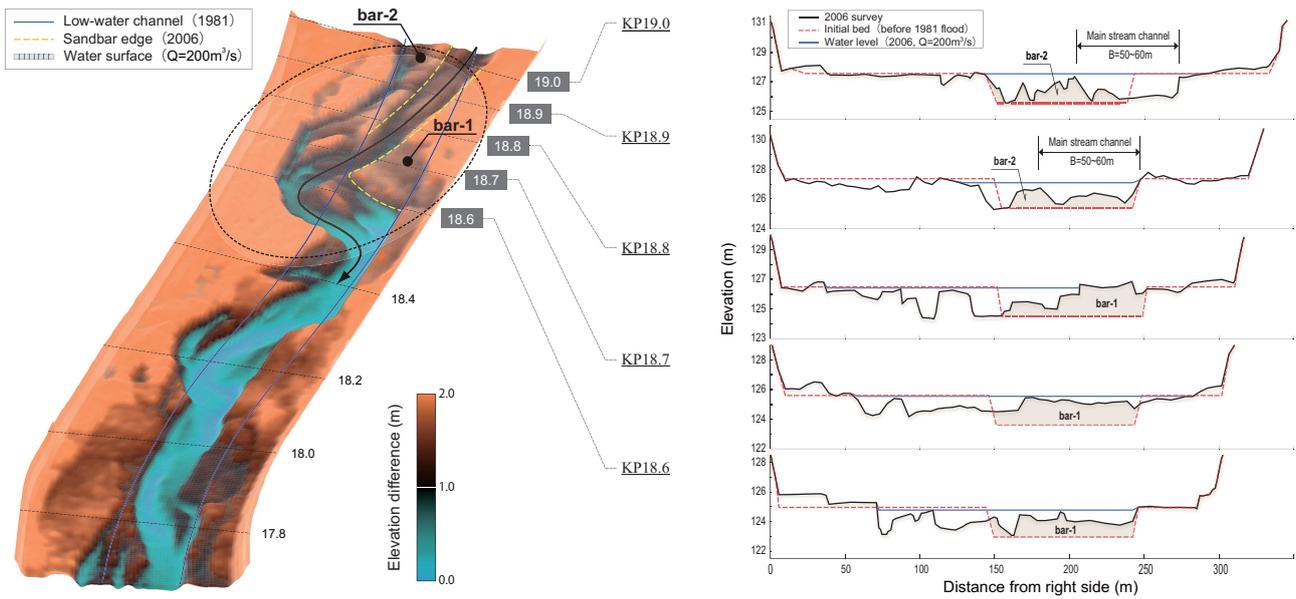
Figure 16. Development of sandbars before the 2011 flood (LP data: 2006.5, Section-2).

First, in order to model the conditions of the river channels to be used in the analysis, the details of the development of the point bars in M-1 before the 2011 flood were confirmed. Figures 16 and 17 show the conditions of the river channel in Section-2 based on the laser profiler (LP) measurement data obtained in 2006. Figure 16 (left) is a bird’s-eye view and Fig. 16 (right) is a transverse section of M-1, while Fig. 17 is a plan view of the riverbed elevation. In the transverse section of M-1, Bar-1, which formed on the left-bank side, developed to the point of completely filling up the low-water channel

that is indicated by the red dotted line for 1981, which shows that solid point bars, whose wave heights were as high as the crest of the riverbank in low-water channel, formed.

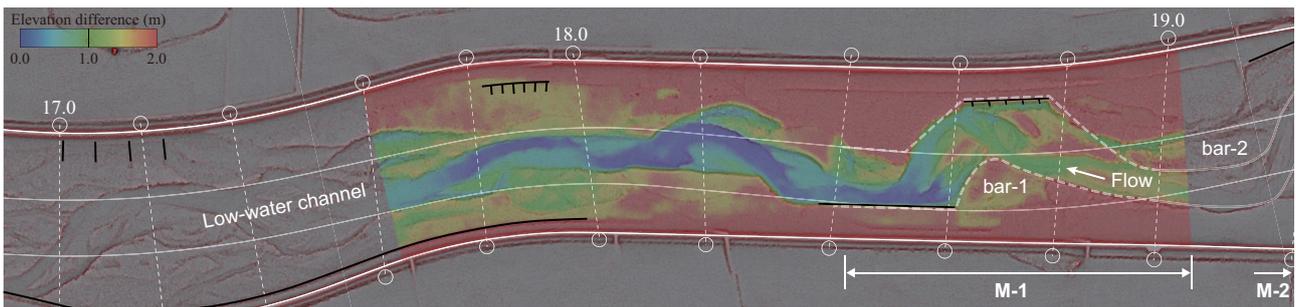
Figure 17. Observed riverbed elevation before the 2011 flood (LP data: 2006.5, Section-2).

Thus, a planform-shaped riverbank that was designed to imitate the meandering path (M-1), as shown by the dotted line in Fig. 17, was formed on the upstream side of the analysis section, and a straight river channel with a 100 m-wide low-water channel was connected to the section on the downstream side. More information on the planar configuration of the riverbank is shown in the uppermost part of Fig. 21.

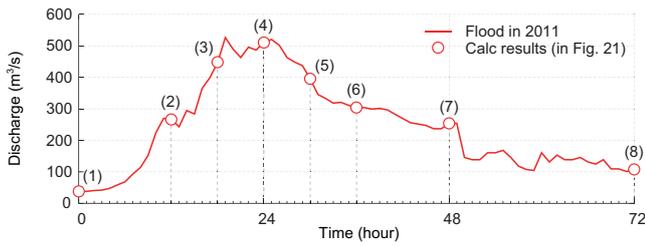
Figure 18. Time display of calculation results (2011 flood).

In this analysis, the 2011 flood (3 days), shown in Fig. 18, was reproduced as an external force, with the purpose of identifying the dominant factors that triggered the development of meandering flows that caused the bank disaster, in addition to the developing process of the meandering flows being examined. The 2 km-long section from KP17.0 to KP19.0 was determined as the section for analysis, and

The calculation results and the actual configuration of the riverbed measured after the flood are shown in Fig. 21. Additionally, the time display of each result corresponds to those of (1) to (6) and (8) in Fig. 18.

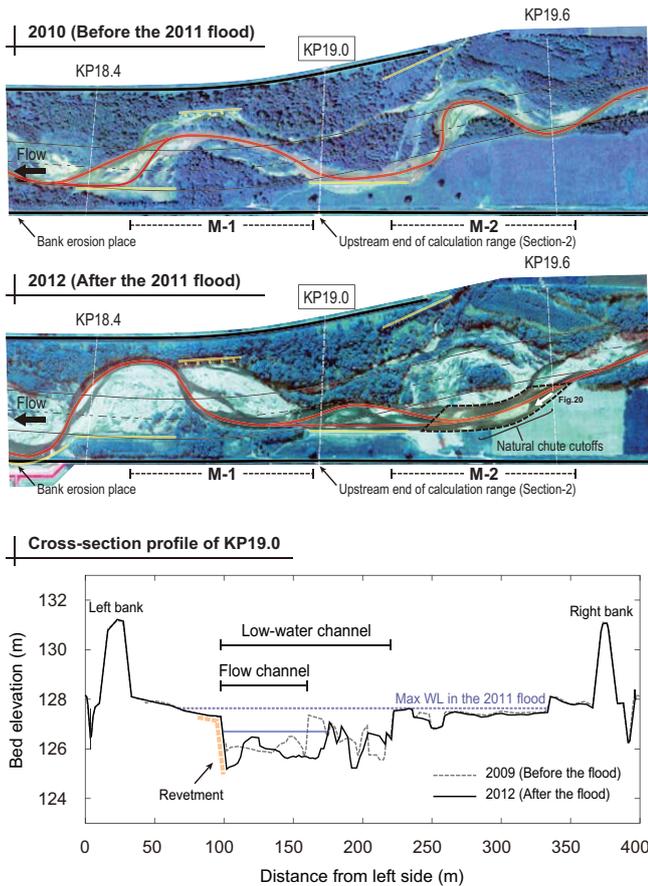
Figure 19. Planform shape of meandering channels and cross-section profiles before and after the 2011 flood (around KP19.0).

Here, supplementary information is given to show the validity of setting KP19.0 as the upstream end of the analysis section. In the area near KP19.0, due to the point bars (M-1 and M-2), the flow running on the left-bank side was maintained even during a flood, and no transverse direction change in watercourse was observed from that shown in Fig. 19.

In addition, at the site, natural chute cutoffs occurred in the meandering flow (M-2; Figs. 19, 20) during the flood; however, there is no major difference between the cross-sectional shape of the river channel near KP19.0 before the flood and after the flood. In this analysis, therefore, it is assumed that the cross-section profile of KP19.0 (upstream end of calculation range) was in a dynamic equilibrium during the 2011 flood.

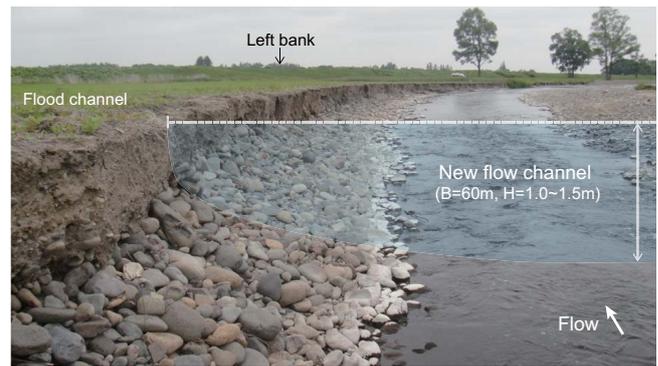
Figure 20. New flow channel caused by the chute cutoffs in M-2.

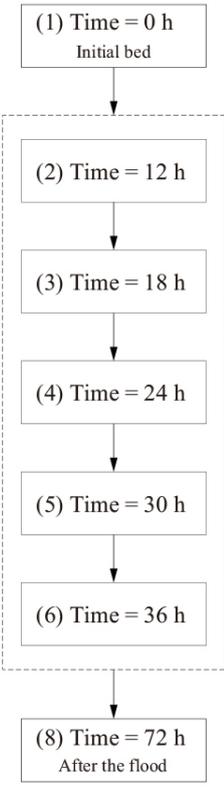
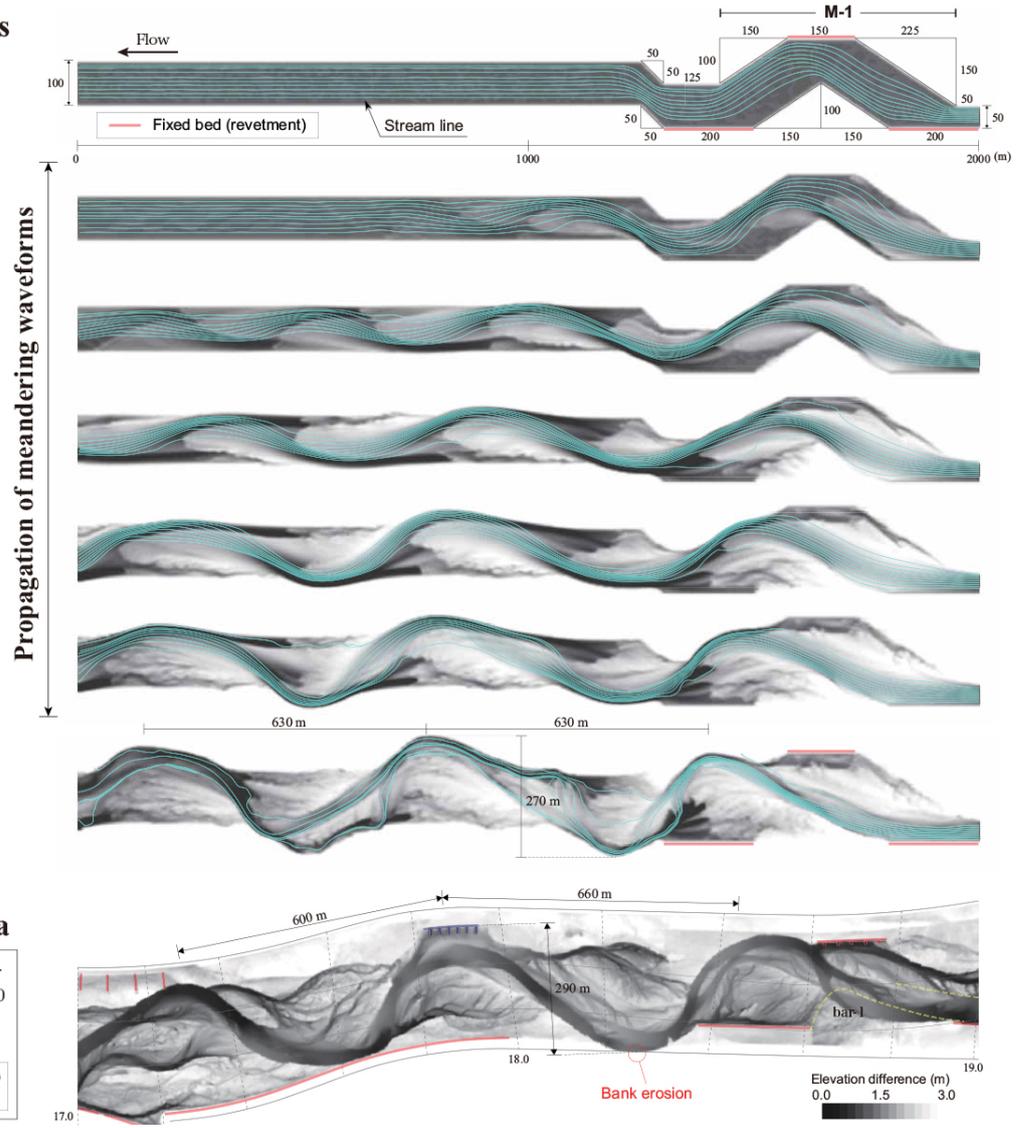
- Survey method: Laser profiler
  - Survey section: KP17.0 ~ 19.0
  - Survey date: 20 May 2012  
(The flood occurred on 7 Sep. 2011)
- Revetment (constructed before the flood)
- Revetment (constructed after the flood)

Figure 21. Calculation results and the actual configuration of the riverbed measured after the flood.

The calculation results confirmed that major changes started to take place in the river channel during the discharge-increase period after the discharge exceeded  $200 \text{ m}^3 \text{ s}^{-1}$ , and the meandering channels took their general form gradually over the period from (2) to (6), around the peak discharge. The changes that took place from (6) to (8) show that only the meandering amplitude was increasing during this period, accompanied by little change in wavelength and phase.

The blue lines show the following change that took place during the period from (2) to (6): the flood flow was restrained in the meander (M-1) due to the curvature of the low-water riverbank, which led to the meandering flow being maintained during the flood. It is considered that, since

The contour figure in the bottom of Fig. 21 shows the actual configuration of the riverbed measured after the flood. Comparing it with the calculation results of (8) indicates

that the calculation results and the measured data are almost identical in terms of the characteristics of meandering flow (wavelength, amplitude). In particular, there are many similarities between the riverbed configuration of (8) and that of measured data, including phase shifting in M-1, traces of sandbar edge and watercourse left on the formed sandbar, which shows that the obtained calculation results are valid.

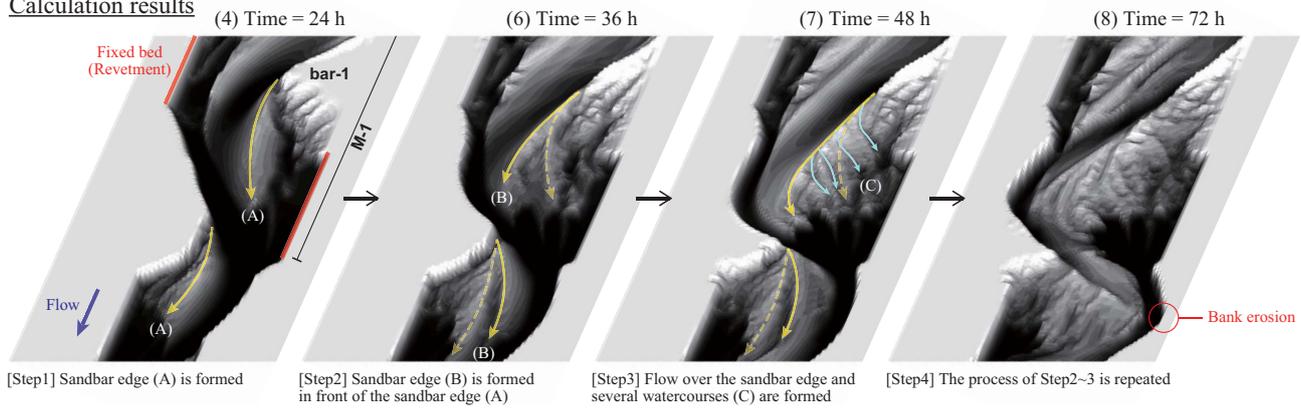
Figure 22. Sandbar evolution process after the peak discharge (traces of sandbar edge and watercourse left on the formed sandbar).

Figure 22 shows the sandbar evolution process that was seen in the upstream side of the bank disaster location during the flood. This calculation result indicates that traces of sandbar edge and watercourse formed through the process shown in this figure (Step 1~4). It is considered that meandering flow rapidly shifted towards the river dike due to the bank erosion, as a result, traces of a transverse scrolling sandbar edge is left on the formed sandbar. These characteristics of traces left on the sandbar are very similar to those of the actual place (Fig. 23).

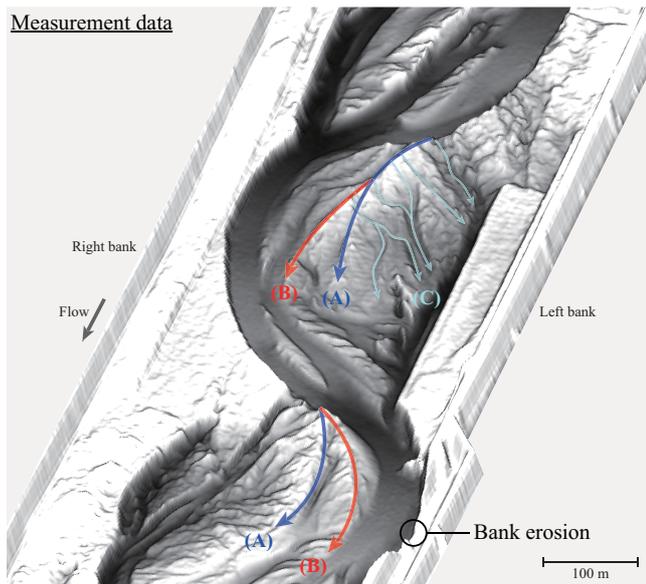
Figure 23. Actual configuration of the riverbed after the 2011 flood.

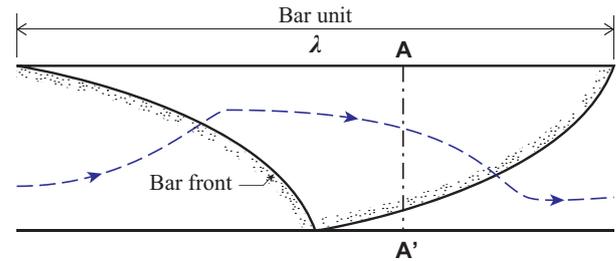
Figure 24. Definition of single-row alternate bars.

In the development of meandering flow, how the cross-sectional profile of a sandbar changes with time is extremely important. Here, the cross-sectional profile of an alternating bar is expressed with wave height  $H_B$  and river width  $B$  (Fig. 24), and the time-series variation of a sandbar profile for representative cross sections of Section-1 and Section-2 are shown in Fig. 25. The upper part of the figure and Eq. (3) show the following: the results from the experiment on the equilibrium wave height of alternating bars that was conducted using a straight channel and the region where the equilibrium wave height could be found, which was indicated by dimensional analysis (e.g., Ikeda, 1983) and onto which the results obtained from this analysis were overwritten. In addition, the lower part of the figure shows the time-series variation of the cross slopes ( $H_B/B$ ).

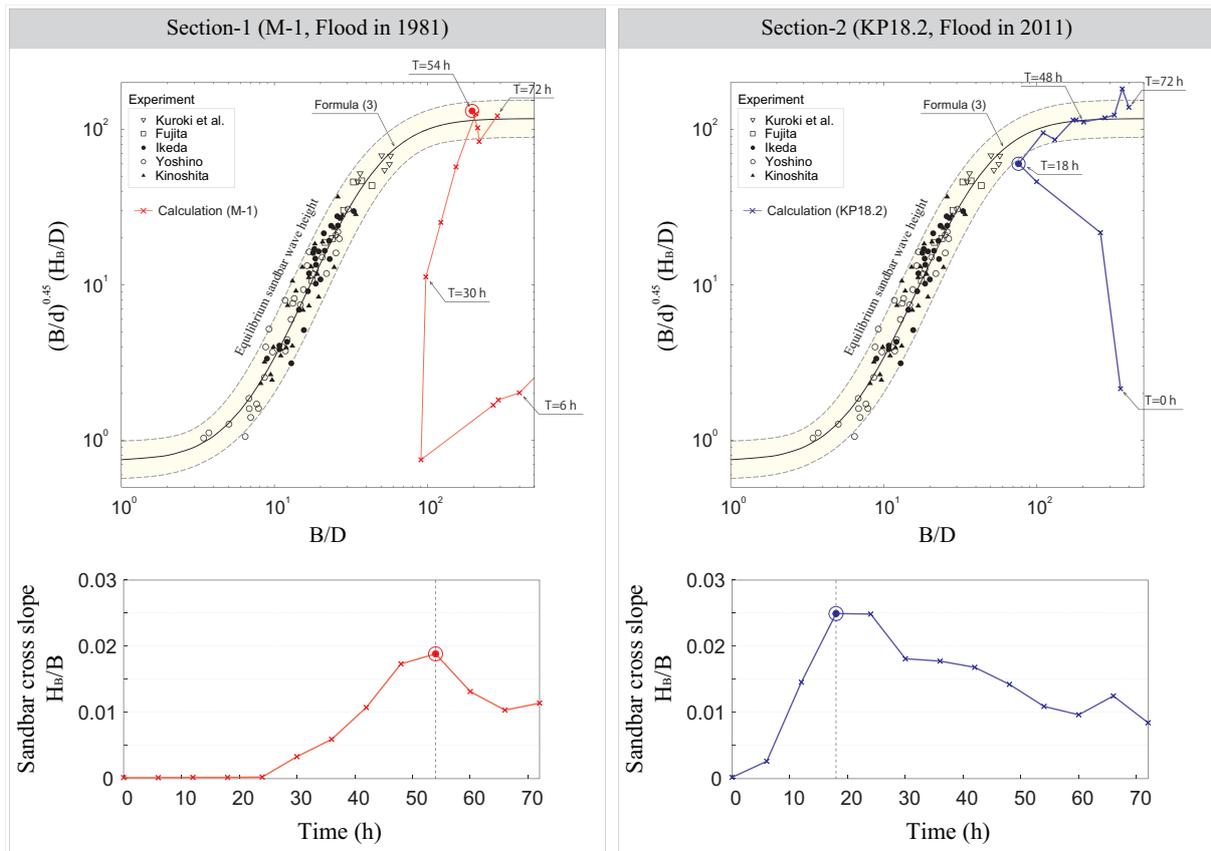
Figure 25. Sandbar wave-height development process and changes of the sandbar cross slope (Sections-1 and 2).

The two sections can be said to have the following two points in common. The first is that the sandbar wave height increases with time; however, after the sandbar wave height reaches the equilibrium wave height, the sandbar moves while maintaining the same state. The second is that the time-series variation of the sandbar cross slope reaches the maximum value when the sandbar wave height reaches equilibrium. Thus, both sections show a convex-shaped variation that has the maximum value as its peak value. This result can be roughly interpreted as follows (Fig. 26).

leads to the development of meandering flows that is more remarkable than that in Section-1. Additionally, the difference in the timing of when the sandbar wave height reaches the equilibrium wave height is brought about by the presence or absence of the remaining traces in the watercourse or sandbars that were produced during previous floods. Therefore, different planform shapes of river bank were given to Section-1 and Section-2 as the initial riverbeds for analysis. If a highly developed sandbar like M-1 exists in a low-water channel, it will cause strong meandering flow during a flood. It is assumed that such meandering flow increases the development rate of sandbars to a great degree (peak arrival time of  $H_B/B$ ).

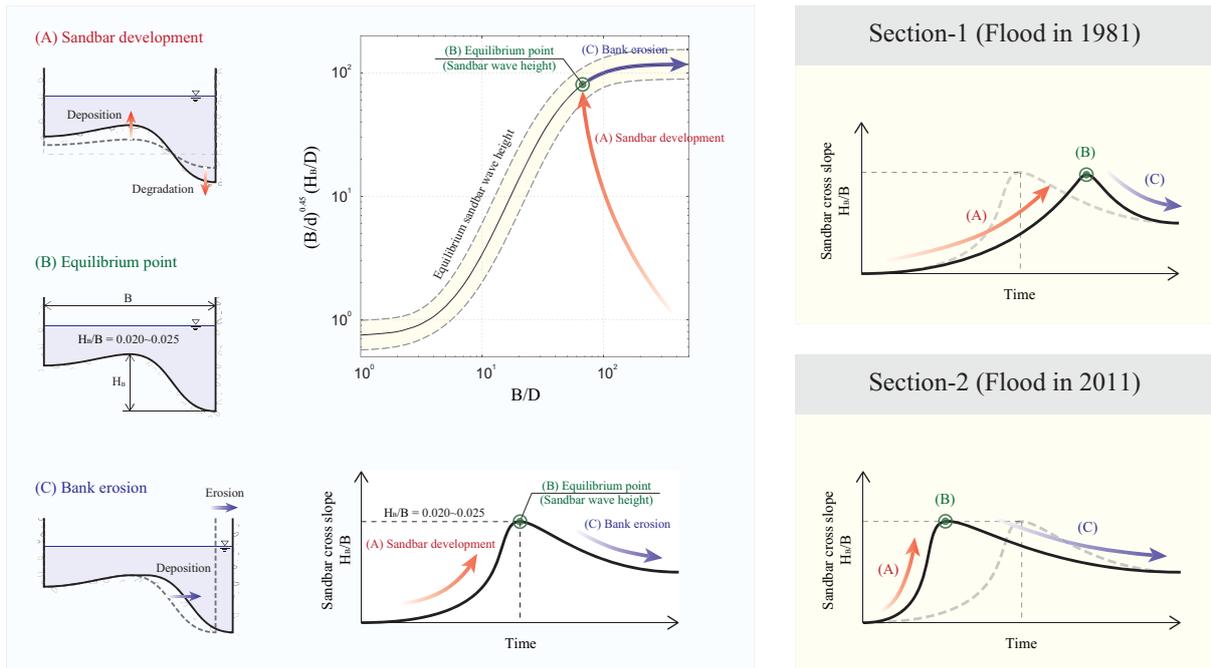
Figure 26. Schematic diagram: change of cross-sectional profile of single-row alternate bars in the flood (Sections-1 and 2).

- Before the wave height has fully developed, the change in the vertical direction predominates (sandbar development process).
- When the sandbar wave height reaches the equilibrium state, the cross slope also reaches its peak ( $H_B/B = 0.020\text{--}0.025$ ).
- After that, the change in the transverse direction predominates, while the equilibrium height is maintained (bank erosion process).
