LARGE-SCALE OPEN-CHANNEL EXPERIMENTS ON THE COLLAPSE OF ABUTMENT BACKFILL OWING TO FLOODS AND PROPOSED COUNTERMEASURE

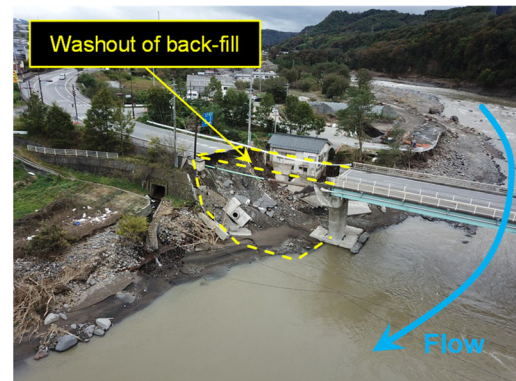
Figure 2 shows the erosion and washout of the backfill of abutments caused by floods in Japan, as investigated by the authors. **Figure 2(a)** shows the case of the 2016 heavy rainfall disaster in Hokkaido³⁾. Erosion and washout of abutment backfill occurred in Eastern Hokkaido, where record rainfall was observed. A road collapse occurred due to loss of the backfill at the back of the abutment. As a result, a car fell the washout area, causing two human deaths and one missing person. At the spread foundation abutment, the abutment was displaced due to scouring of the foundation ground, and restoring the bridge took time. **Figure 2(b)** shows a case in which abutment backfill flowed out due to record rainfall in the northern Hokkaido area in 2018⁵⁾. Damage to the abutment backfill affected the transportation of agricultural crops in the farming season. **Figure 2(c)** shows a case of damage by Typhoon No. 19 (Hagibis, SSHWS; Category 5), which caused large-scale damage throughout East Japan in 2019. In this flood, a bridge over the Chikuma River middle basin in Nagano Prefecture suffered a loss of abutment backfill, with three cars falling down and three persons being injured as a result.

(a) Yunosawa bridge, Eastern Hokkaido, 2016.9

(b) Antaroma bridge, Northern Hokkaido, 2018.7

(c) Tanaka bridge, Central Nagano, 2019.9

Fig.2 A typical disaster case in Japan investigated by the authors.

Figure 12 shows the model abutments used in all experimental cases. The model abutment is a reinforced concrete structure of the footing foundation type with a height of 0.8m and a width of 0.96m. According to a field survey shown in Fig. 2, many of the damaged abutments had no sidewalls, but small wing walls were attached. This model abutment was intentionally set to a large blockage rate by projecting 0.2m in Case-1 and Case-3 and 0.3m in Case-2. This experimental state reproduces the condition before the river flow inhibition rate was severely limited. The measurement items under experiment are pore water pressure in the model embankment measured by a pore water pressure gauge, river water level in the river channel measured by a water level gauge, and displacement of the model embankment crest as determined by surveying.

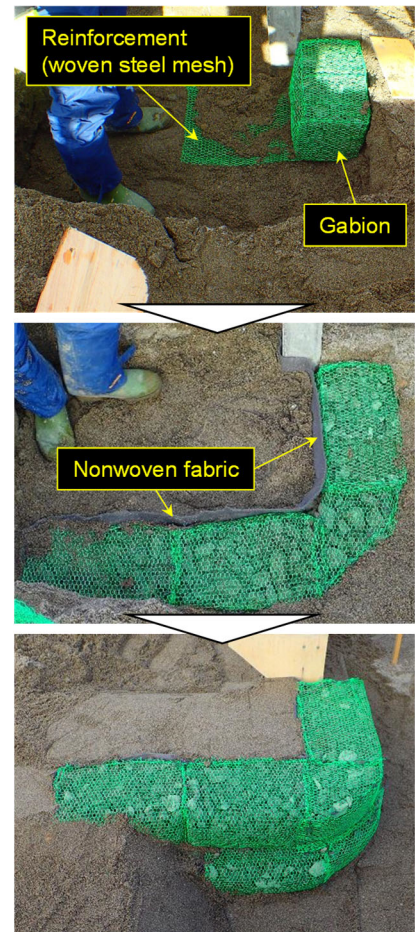
Figure 10 shows production underway on the model of the gabion-reinforced soil wall used as the countermeasure method installed in Case-3. Here, the gabion-reinforced soil wall uses a gabion with a height of 1 m, a width of 1 m, and a length of 2m shown in Fig. 11(a) as wall material. The gabion-reinforced earth wall uses hexagonal wire mesh with a length of about 2 m that is integrated with this wall material as a reinforcement (see Fig. 11(b))^{16), 17)}.

Fig.10 Construction process of model gabion-reinforced soil wall.

In this test, as a unit of the gabion-reinforced earth wall model, a wall cage made of hexagonal wire mesh with a height of 0.2m, depth of 0.2m, and length of 0.4m was used as the wall material. A 0.3m-long tortoise wire mesh reinforcement was attached to the wall material. A gabion-reinforced clay wall model was installed with three units in the height direction, two units in the road extension direction, and one unit in the road crossing direction. Triangular prismatic gabion-reinforced soil was prepared and installed at the corners. In addition, one unit (height 0.2m) was buried under the riverbed. Also, non-woven fabric
